BEST PRACTICES FOR BICYCLE TRAIL PAVEMENT CONSTRUCTION AND MAINTENANCE IN ILLINOIS

Research Report FHWA-ICT-12-009

**Developing Best Practices for Bicycle Trail
Pavement Construction and Maintenance in Illinois**

June 2012

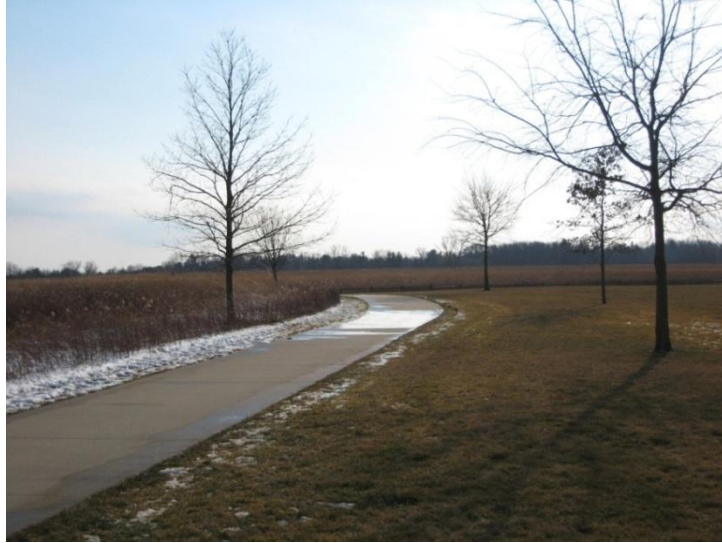
Figure D.3. Standoff between trees and trail.

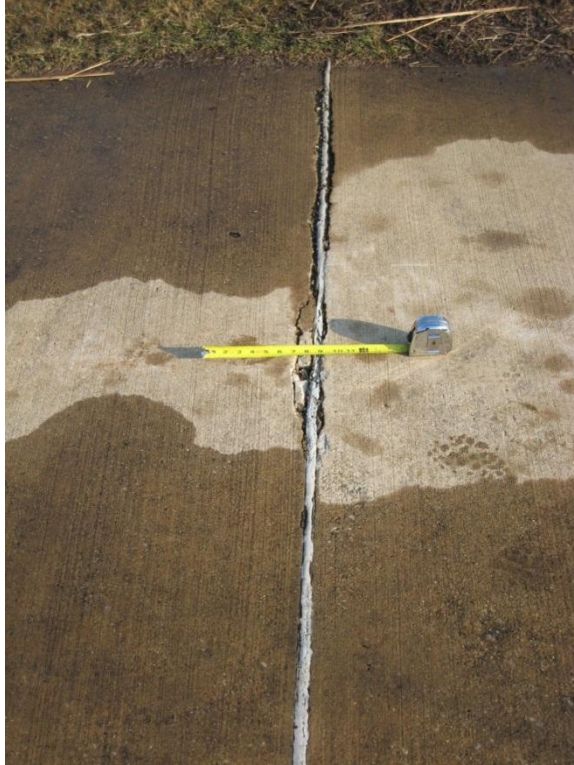
Figure D.6. Joint deterioration due to failing sealant.

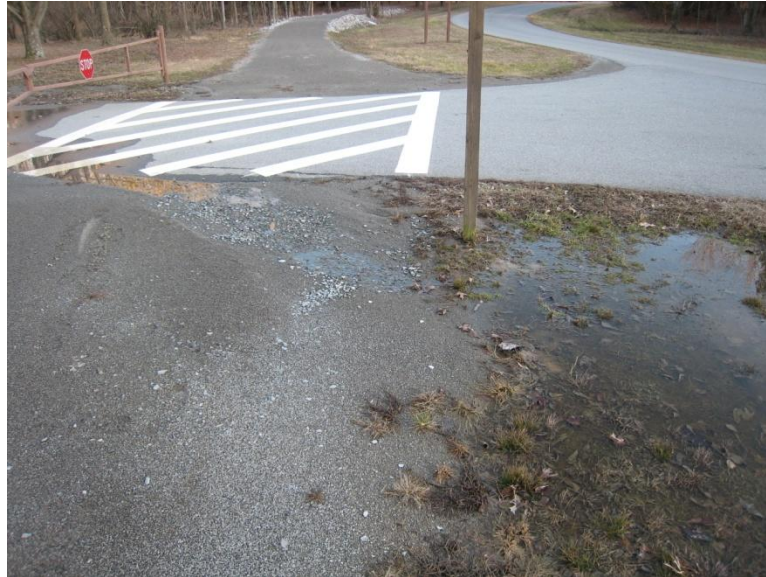
Figure D.20. Additional drainage elements needed in some locations.

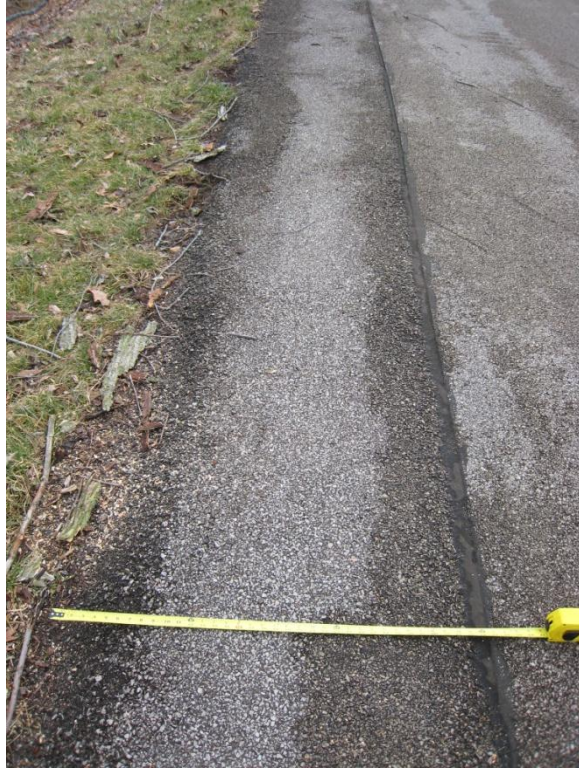
Figure D.34. Patch correcting edge cracking.
