# PRR 165 – Performance of Mechanistically- Designed Pavements

2012 – 2015 Data

John Senger, P.E.

Illinois Department of Transportation -  
Bureau of Research

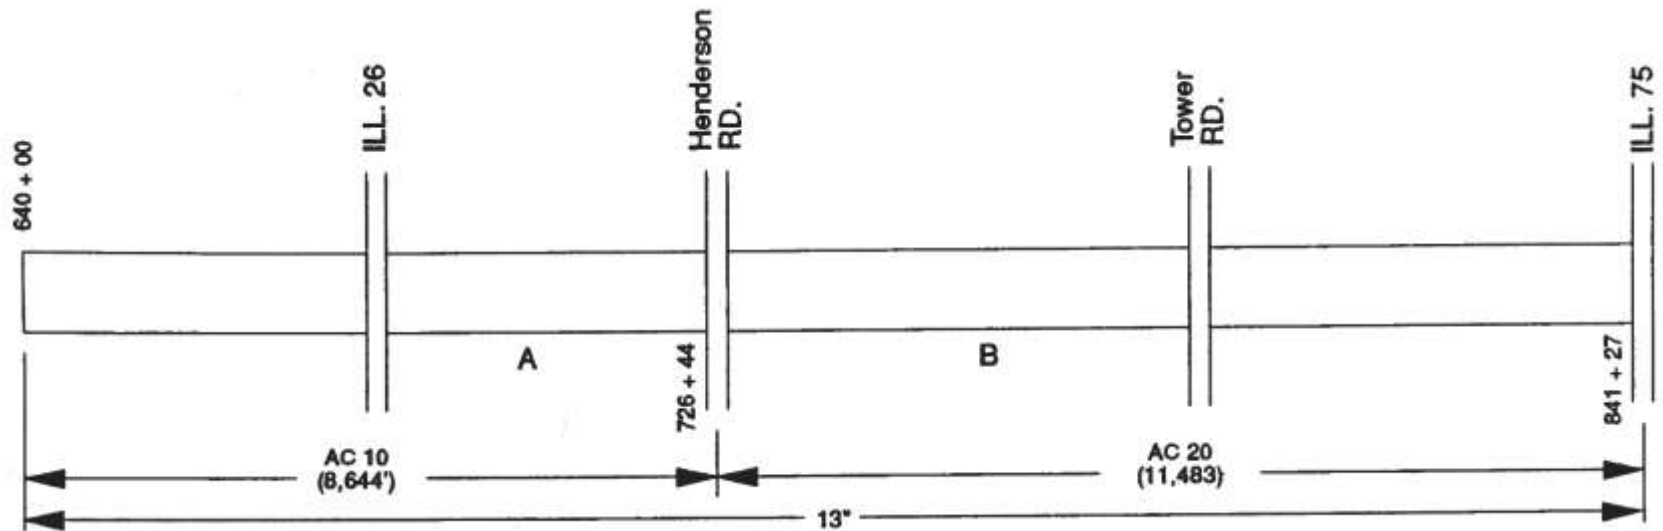
Figure 2 from PRR 112

## FA 401 FLEXIBLE PAVEMENT EXPERIMENTAL LAYOUT

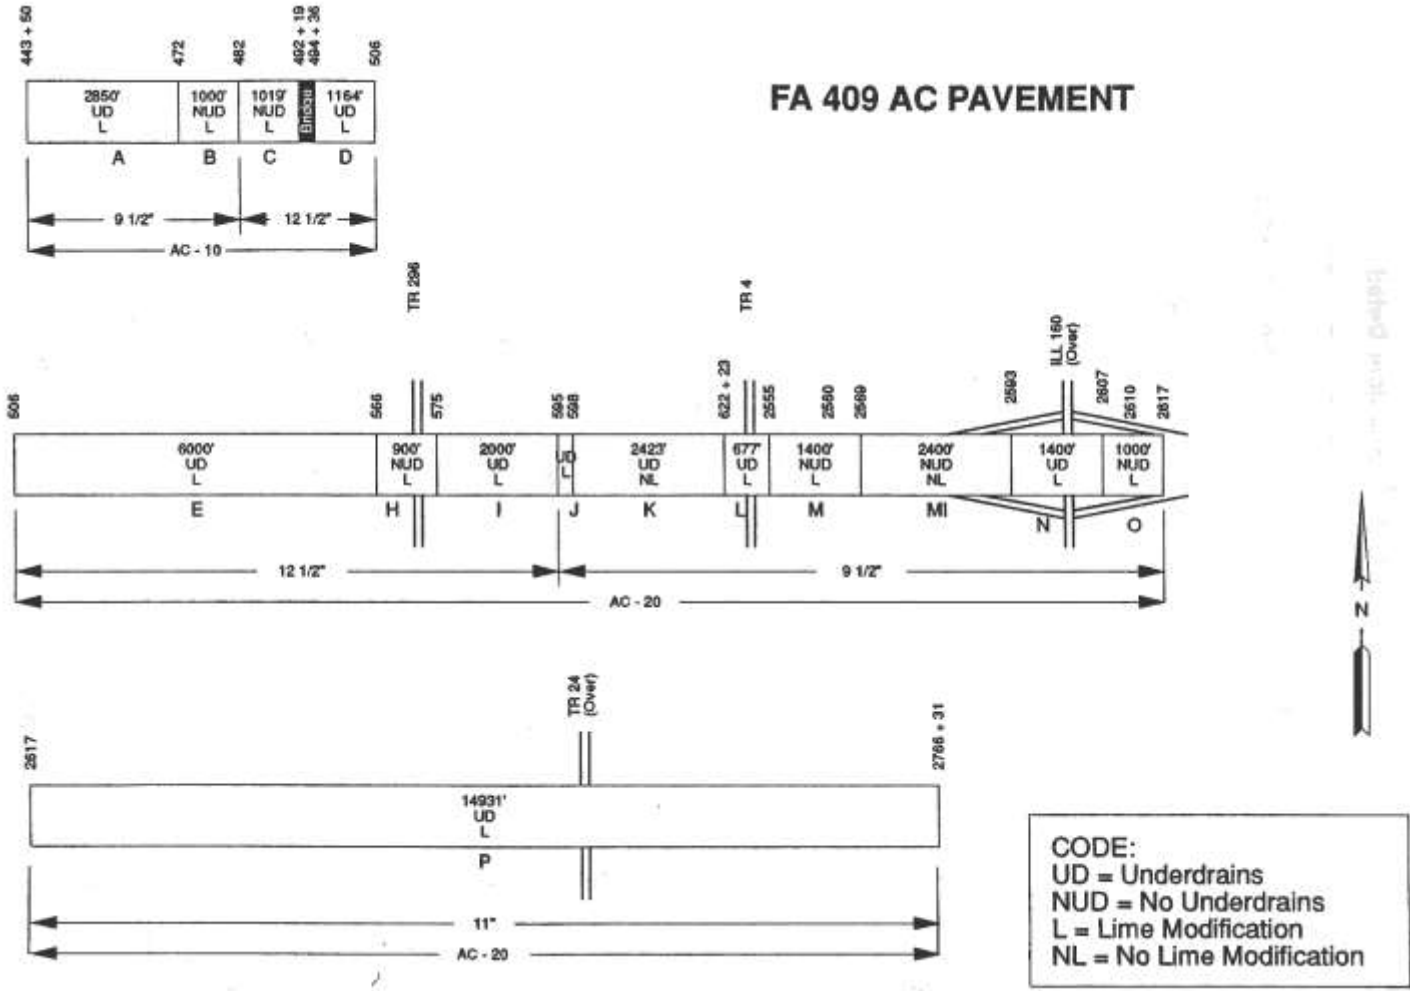
Figure 3 from PRR 112

# FA 409 (US XX)

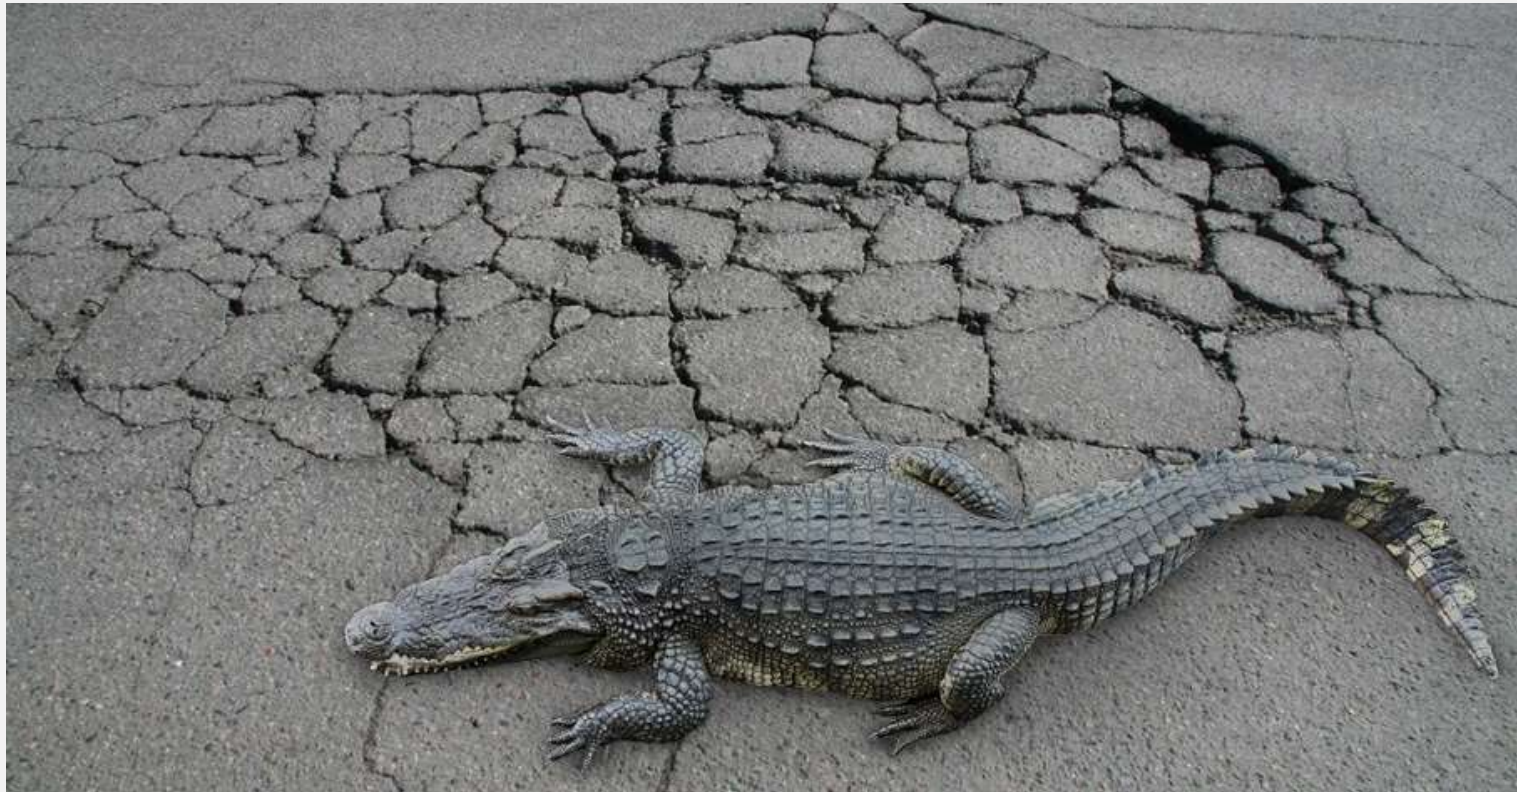
# Alligator or Fatigue Cracking

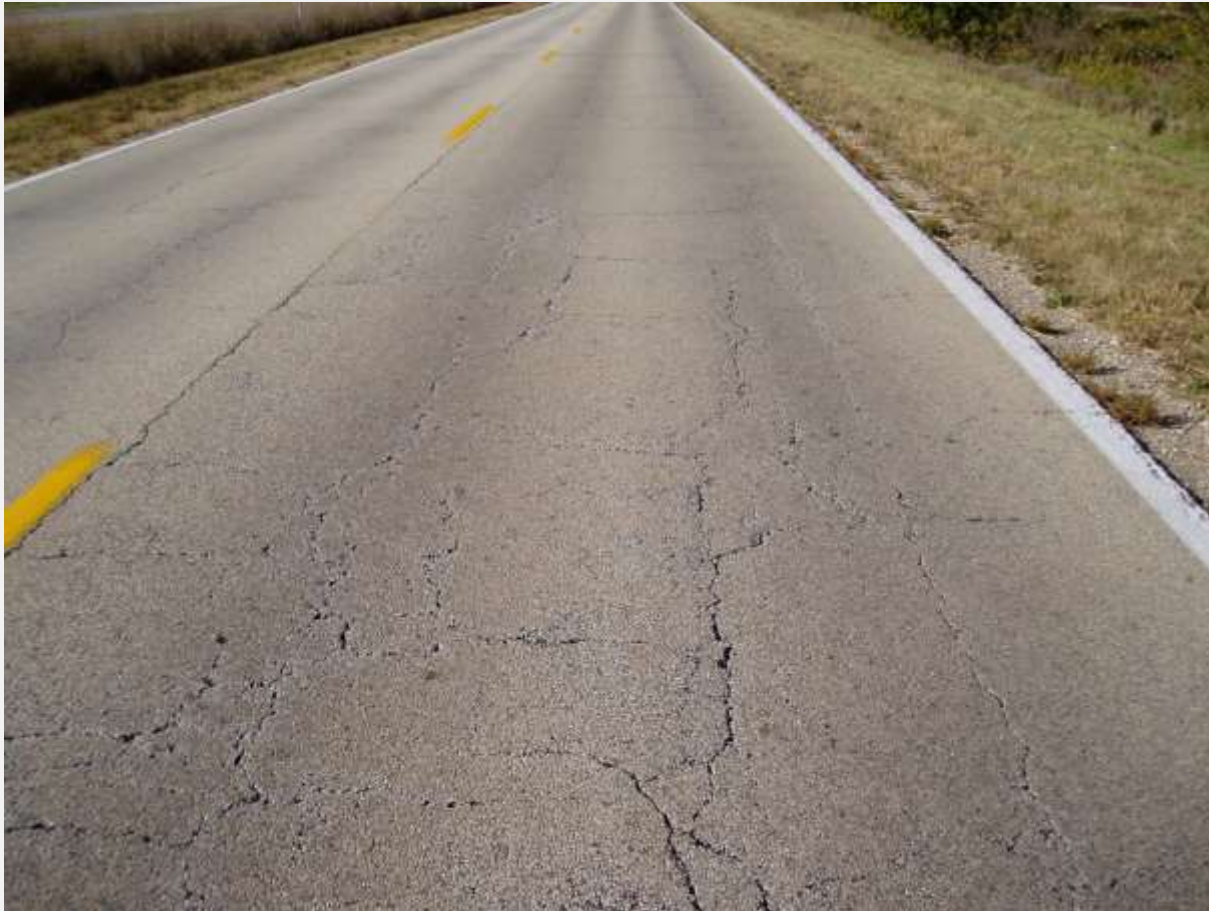
# Block Cracking

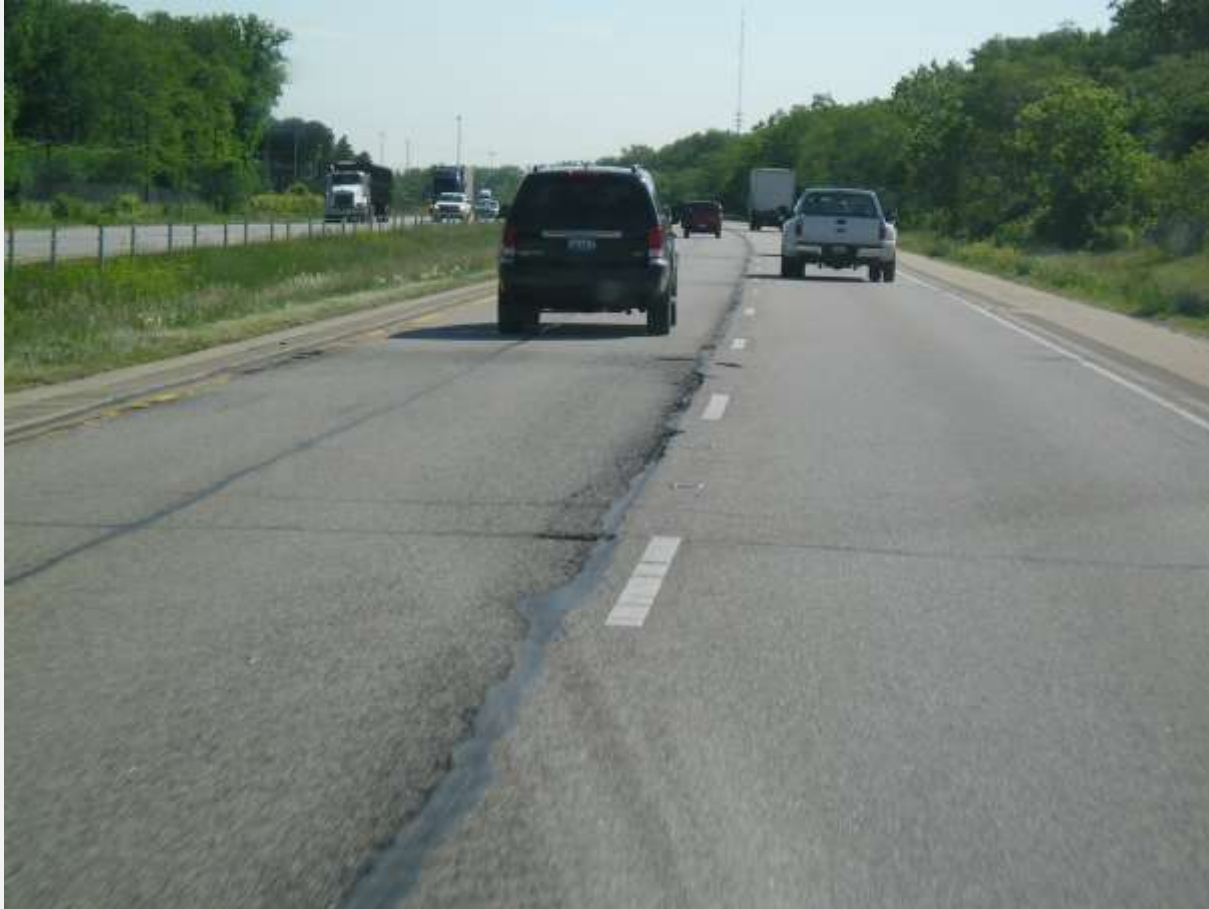
# Centerline Cracking

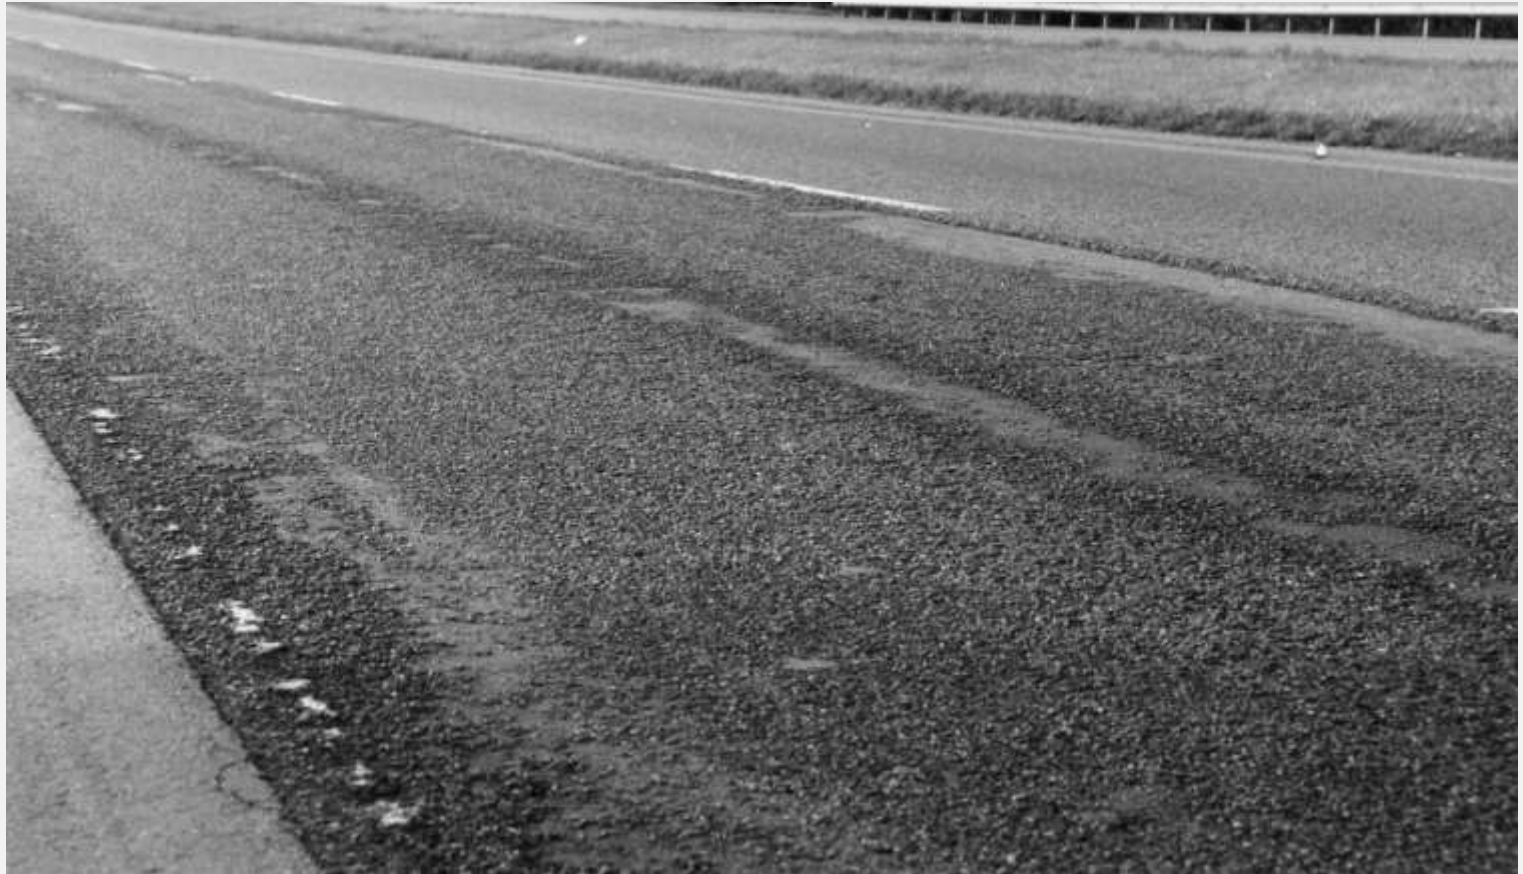
# Raveling and Weathering

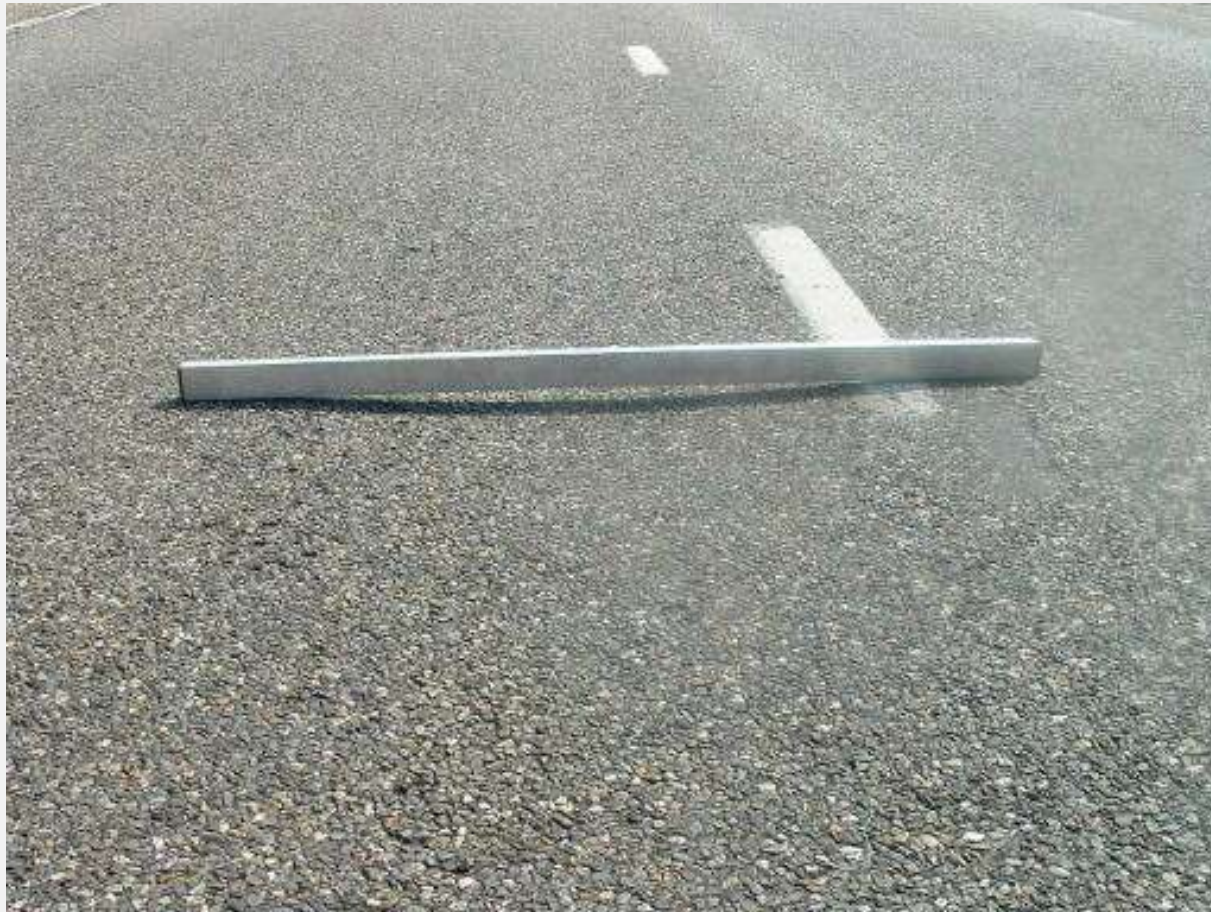
# Rutting

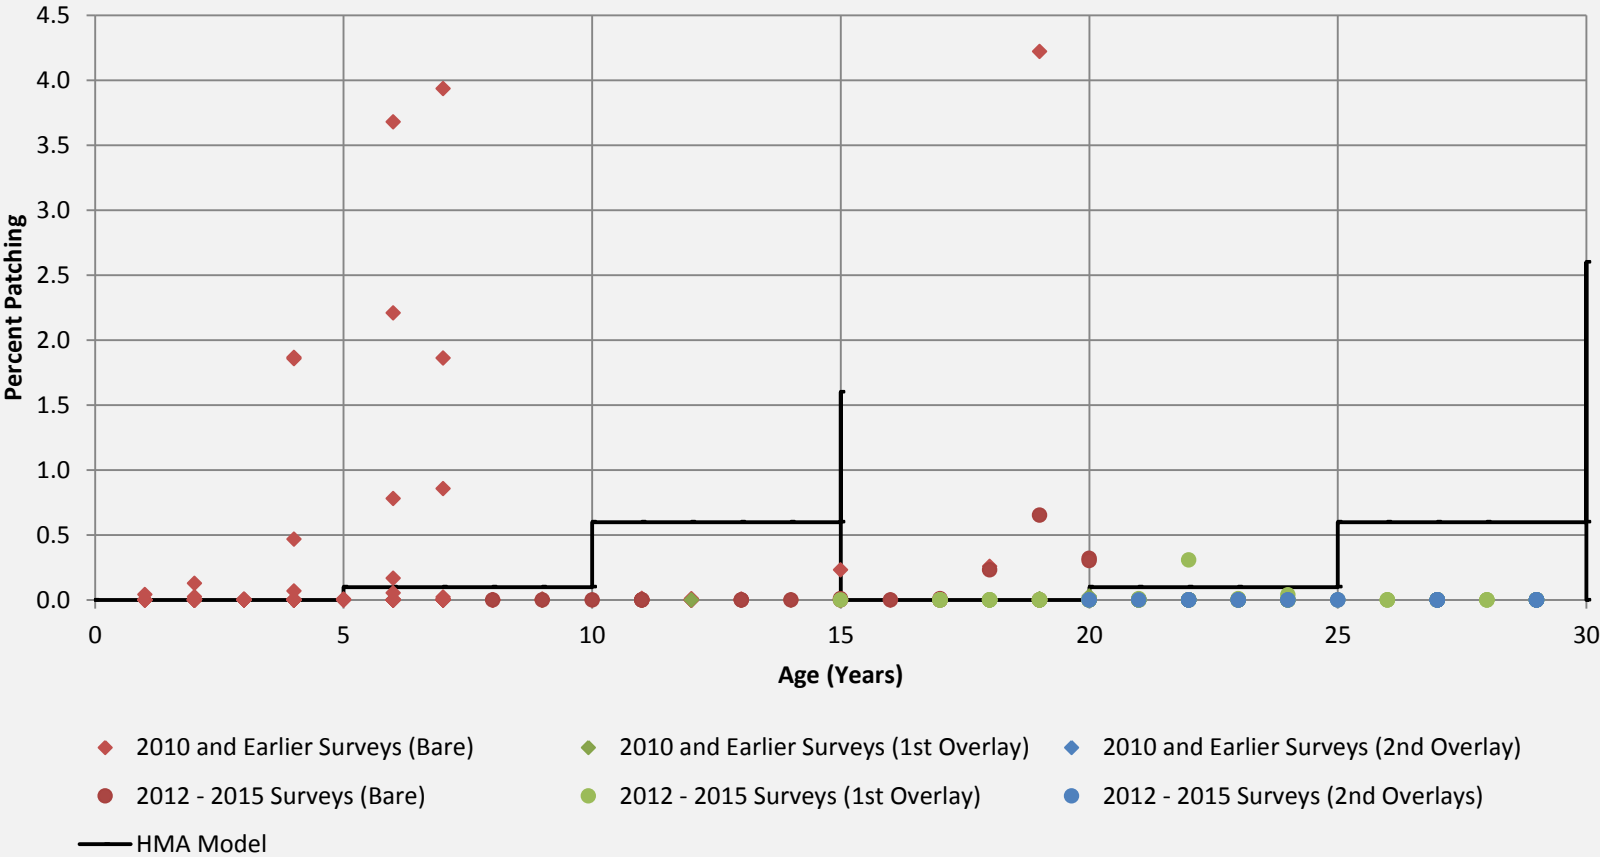
# Figure 2 – PRR 165 Percent Patching

Figure 2: Percent Patching as a Function of Age:  
Full-Depth HMA - All Sections

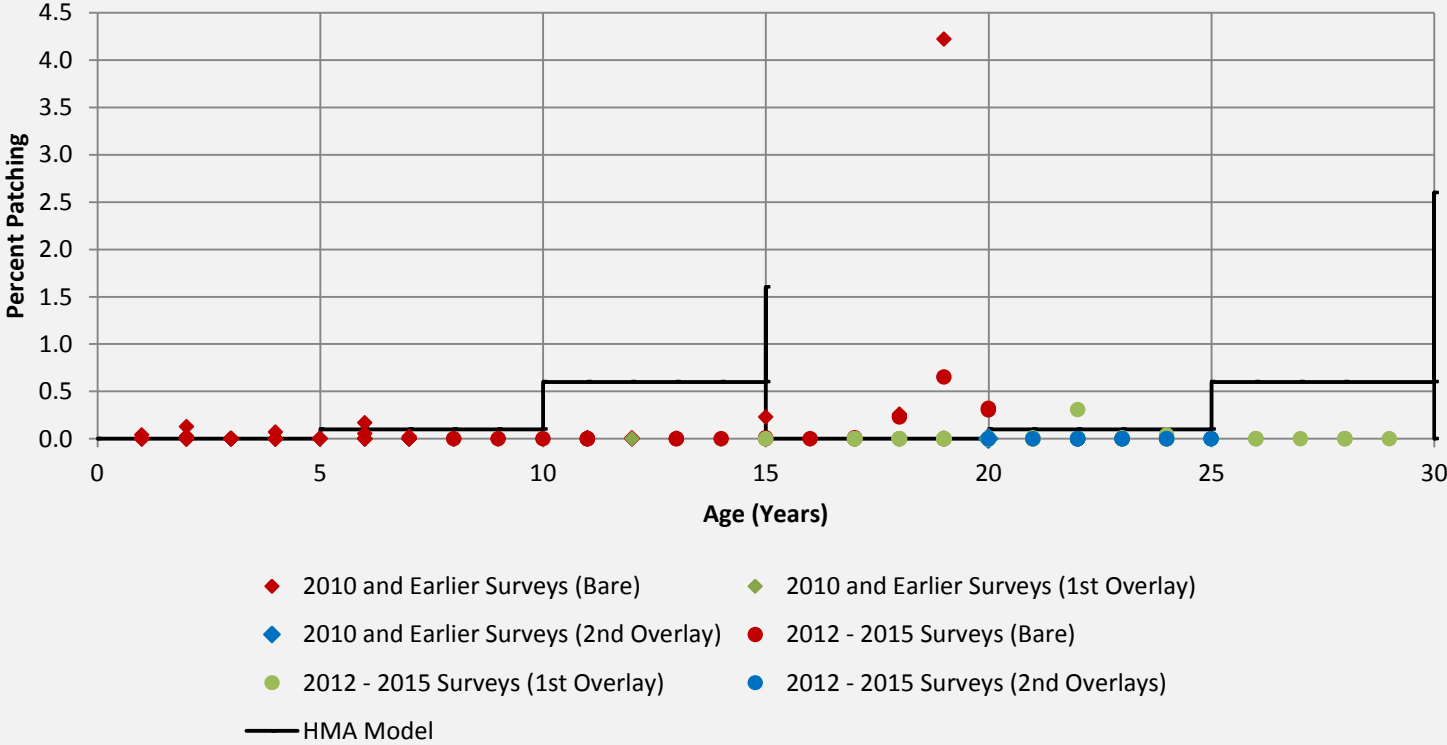
# Figure 3a – PRR 165 Current Design Percent Patching

Figure 3a: Percent Patching as a Function of Age:  
Full-Depth HMA - Current Design Criteria

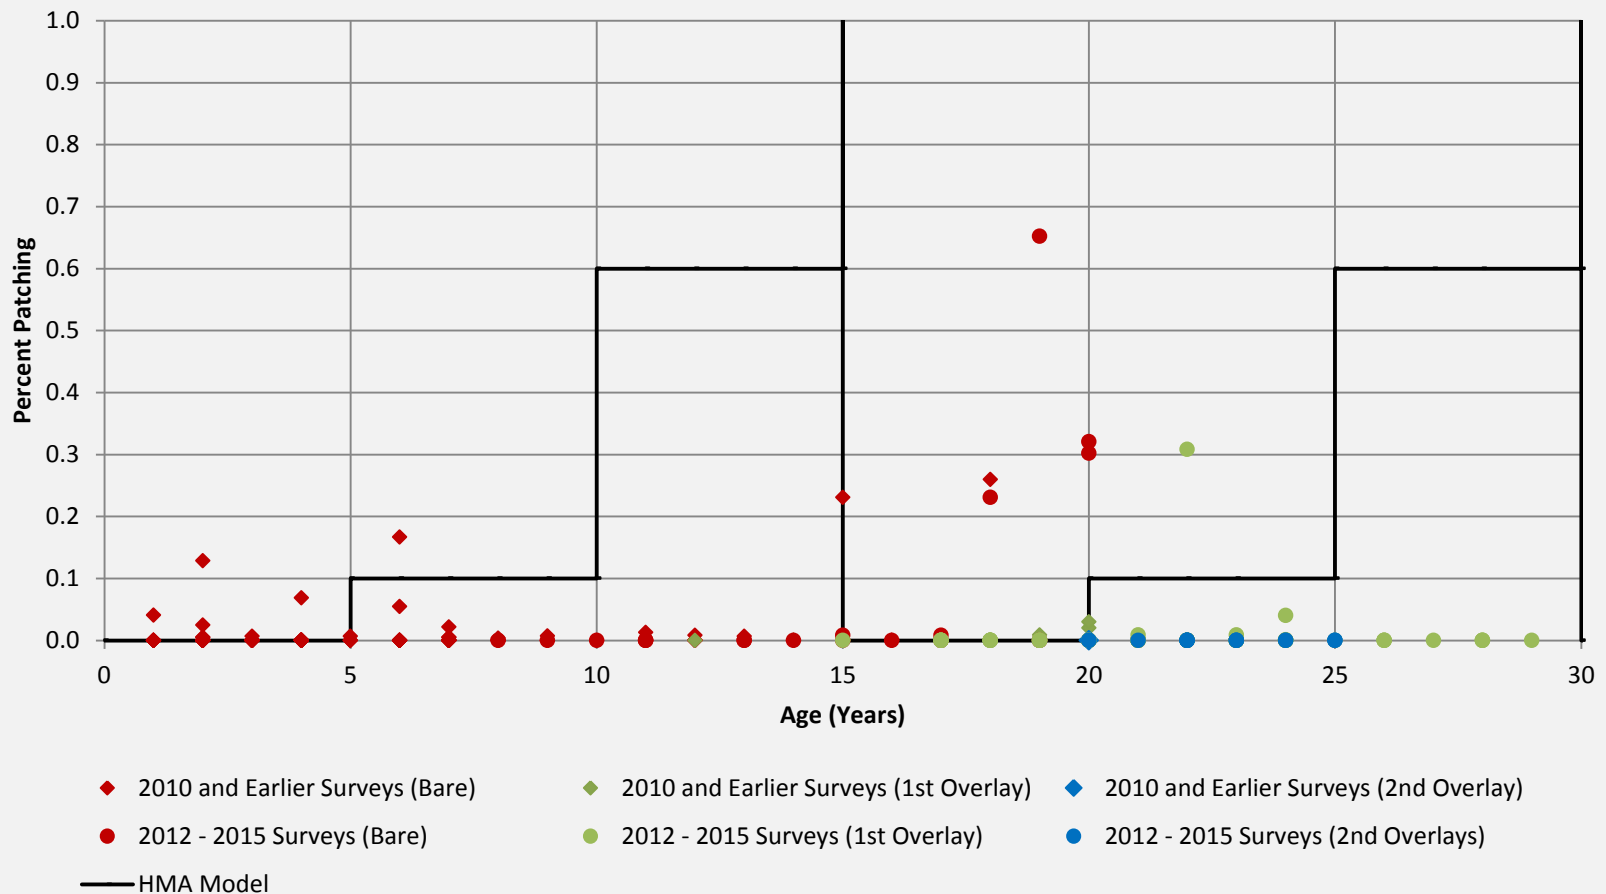
# Figure 3b – PRR 165 Current Design Percent Patching

Figure 3b: Percent Patching as a Function of Age:  
Full-Depth HMA - Current Design Criteria (Expanded View)

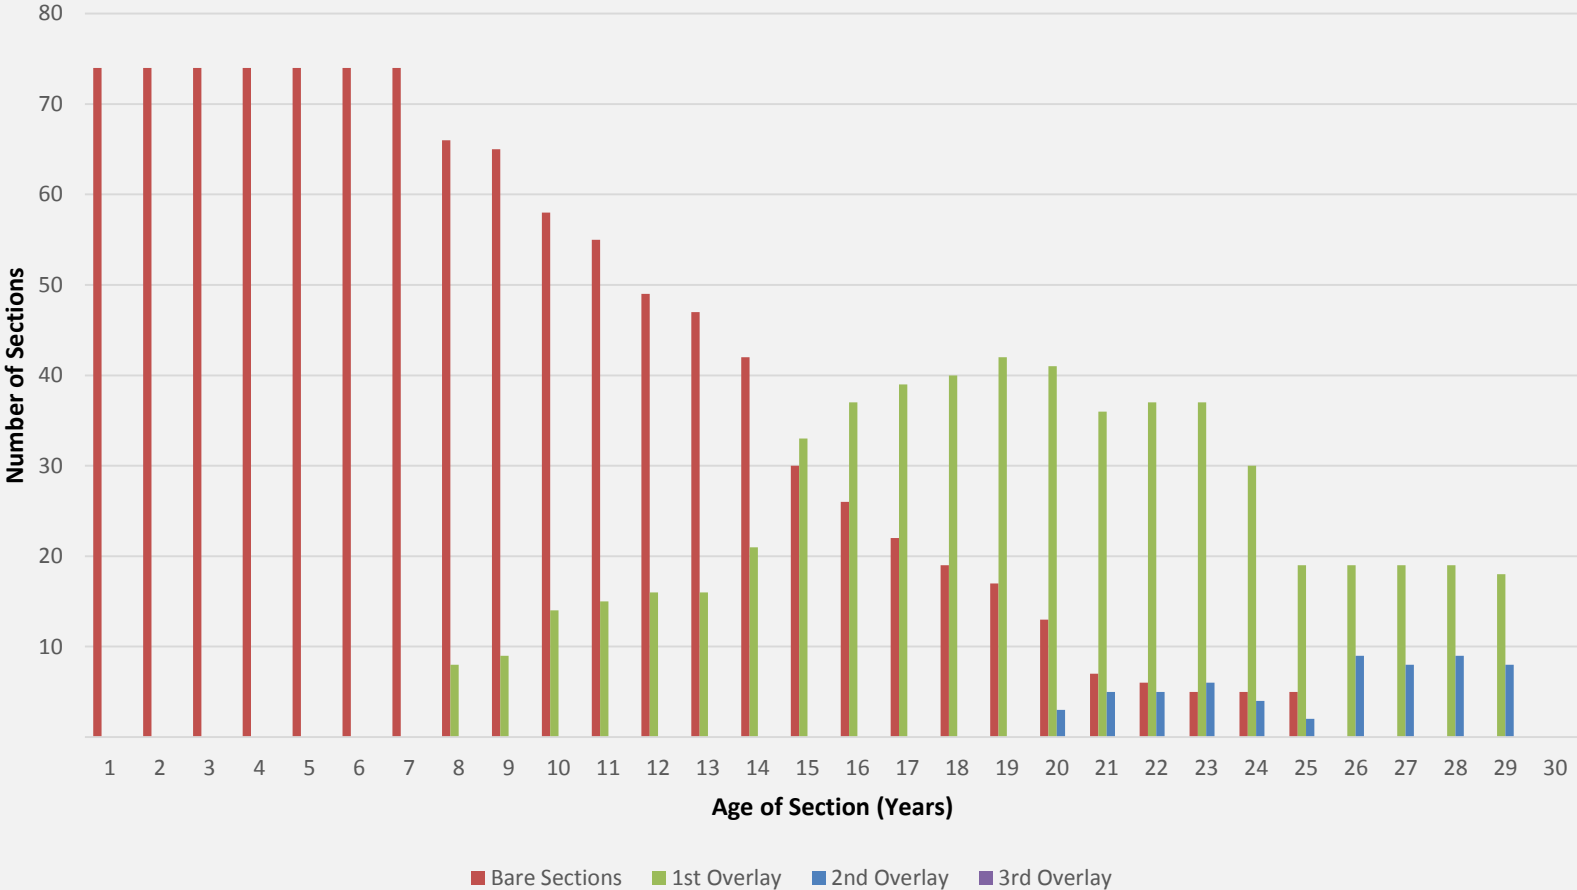
# Figure 11 – PRR 165

Figure 11: Overlays as a Function of Age:  
Full-Depth HMA - All Sections

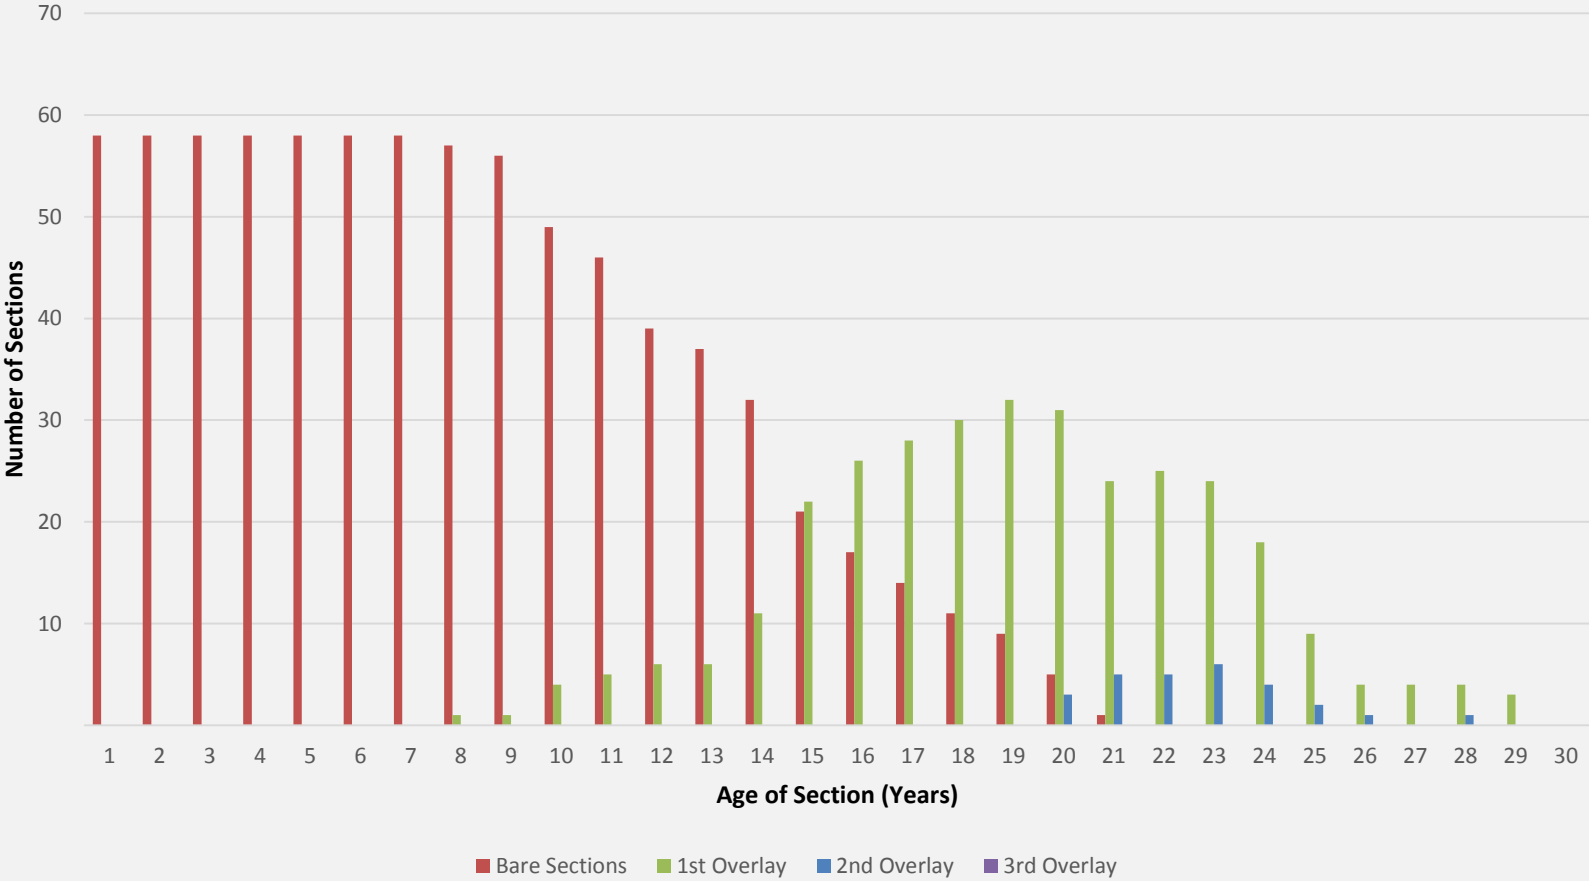
# Figure 12 – PRR 165

Figure 12: Overlays as a Function of Age:  
Full-Depth HMA - Current Design Criteria

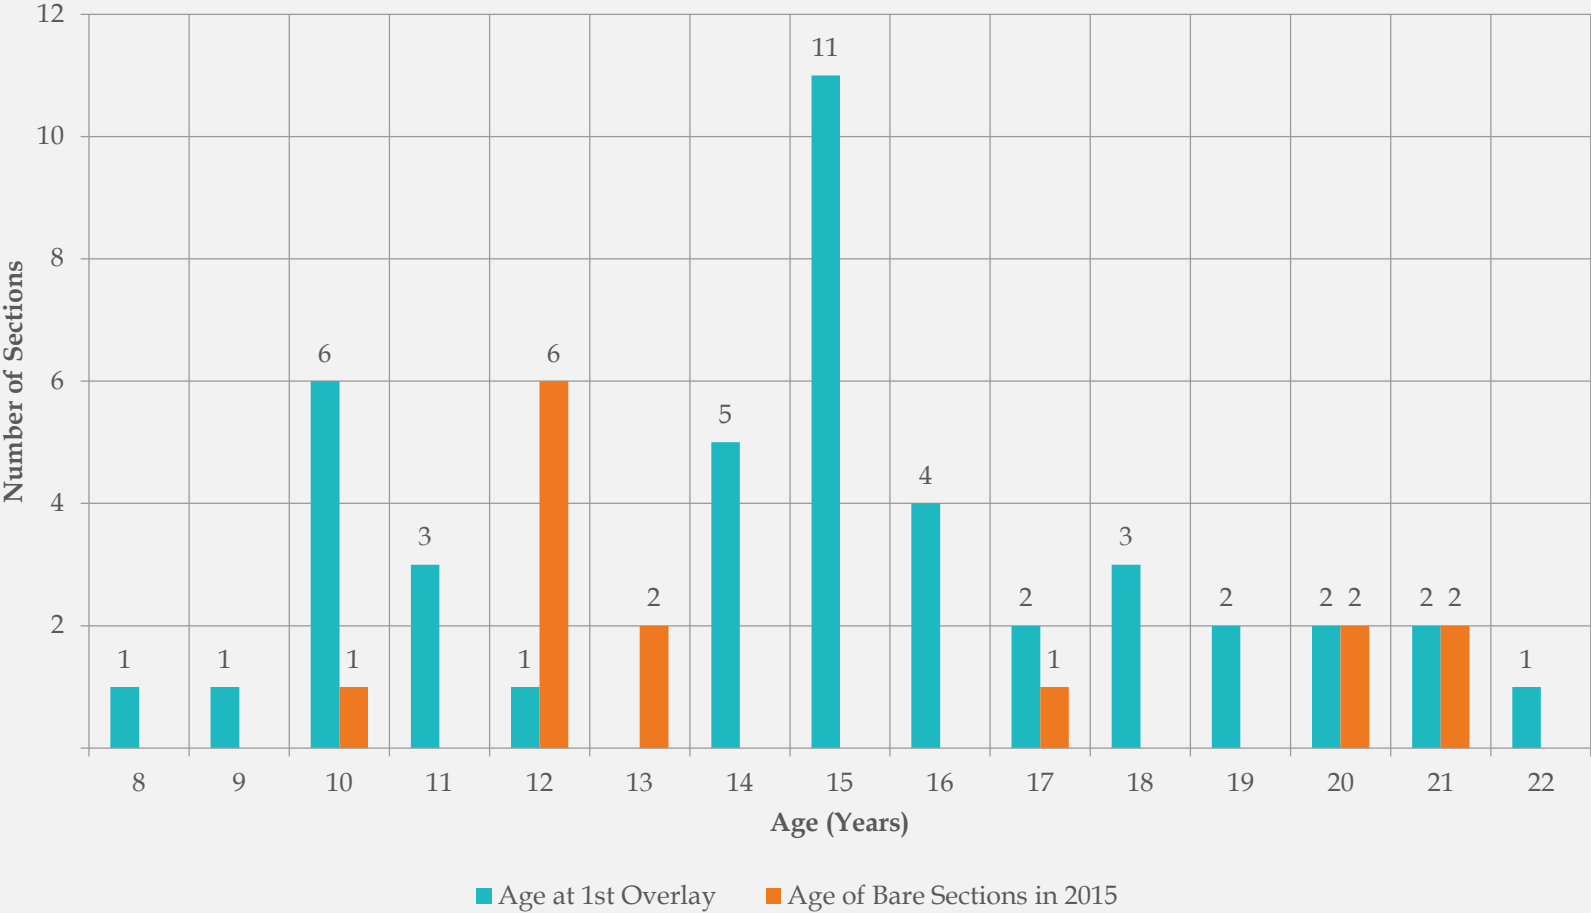
# Service Life of Initial HMA Wearing Surface

Figure 13: Age of Sections: Full-Depth HMA Sections - Current Design Criteria

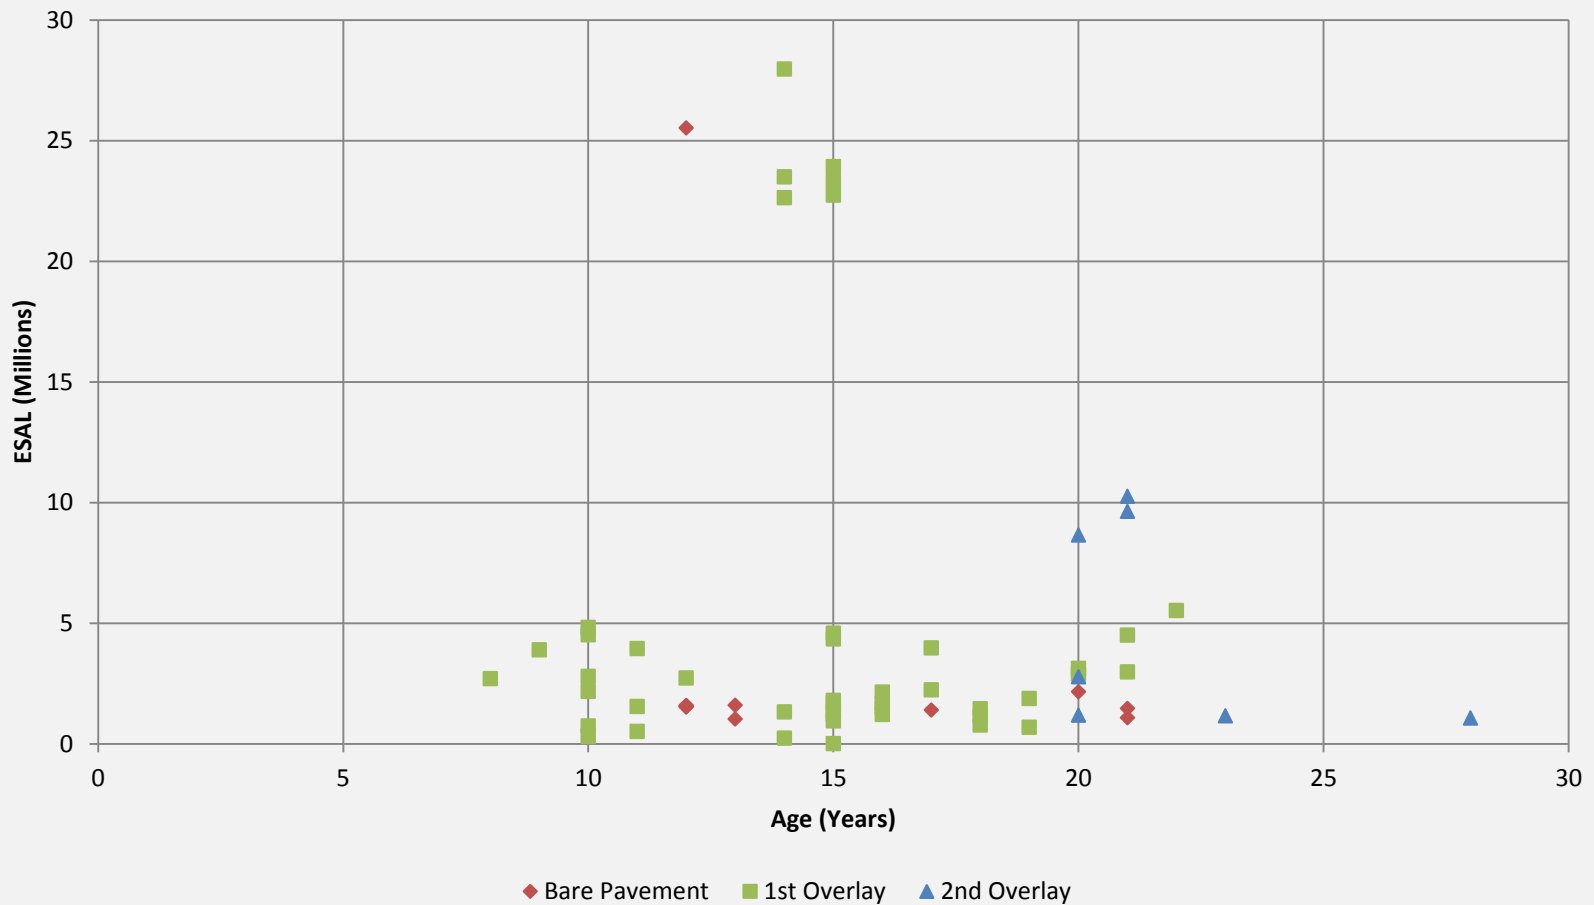
# Figure 24 – PRR 165 ESALs

Figure 24: ESALs as a Function of Age:  
Full-Depth HMA - Current Design Criteria

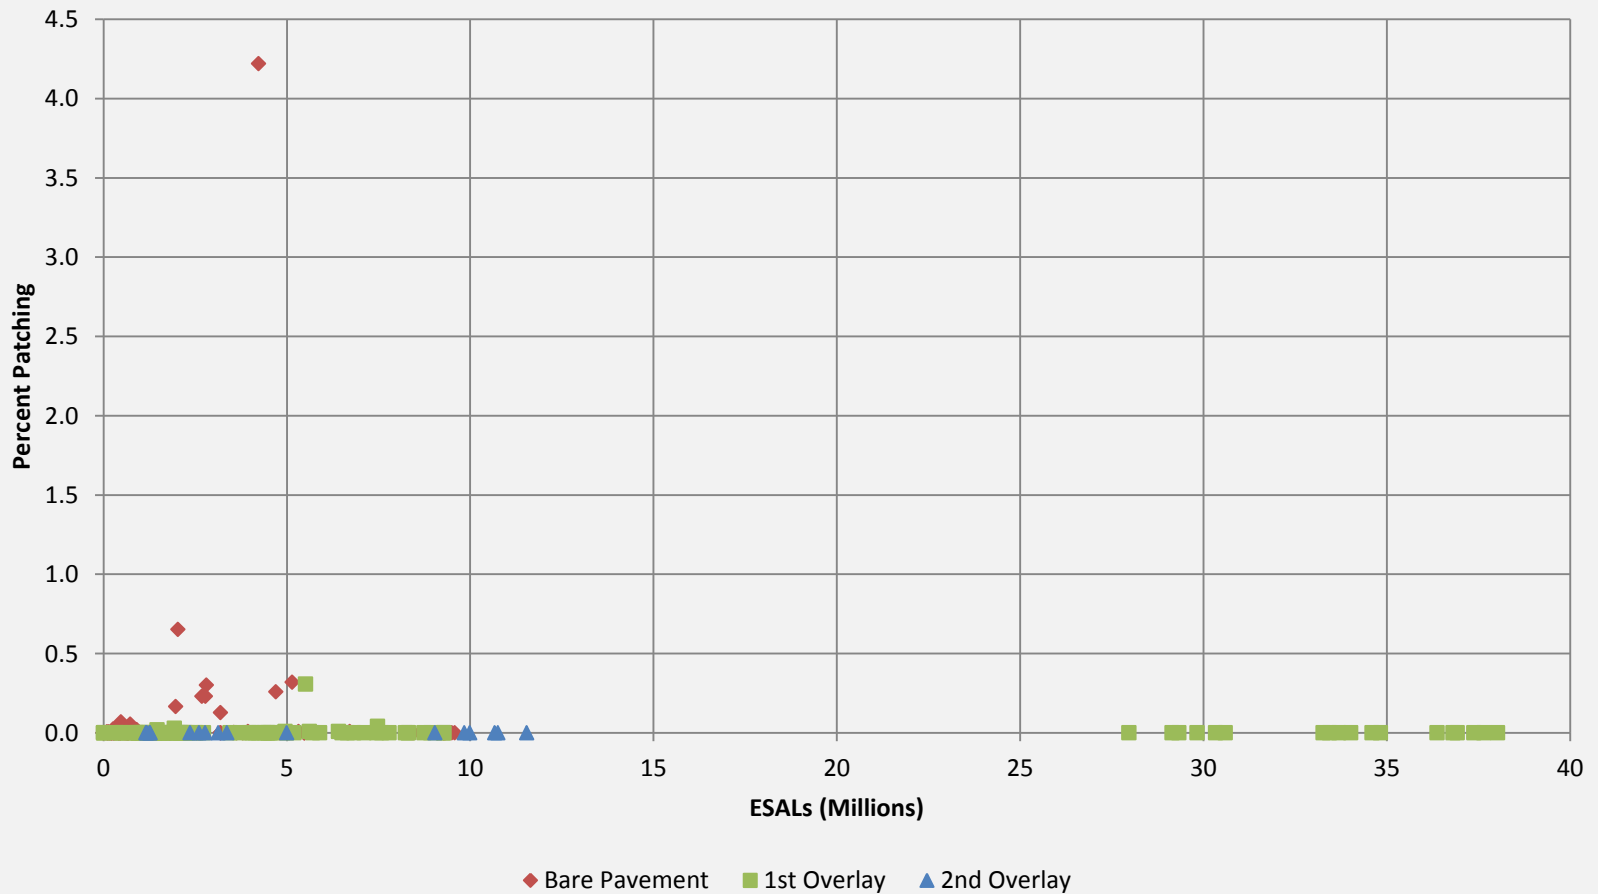
# Figure 27 – PRR 165 ESALs and Patching

Figure 27: Percent Patching as a Function of ESALs:  
Full-Depth HMA - Current Design Criteria
