Performance of Interstate Rubblization in Illinois

Charles J. Wienrank, P.E.
Pavement Design Engineer
IDOT – Bureau of Research

IAPA 85th Annual Convention

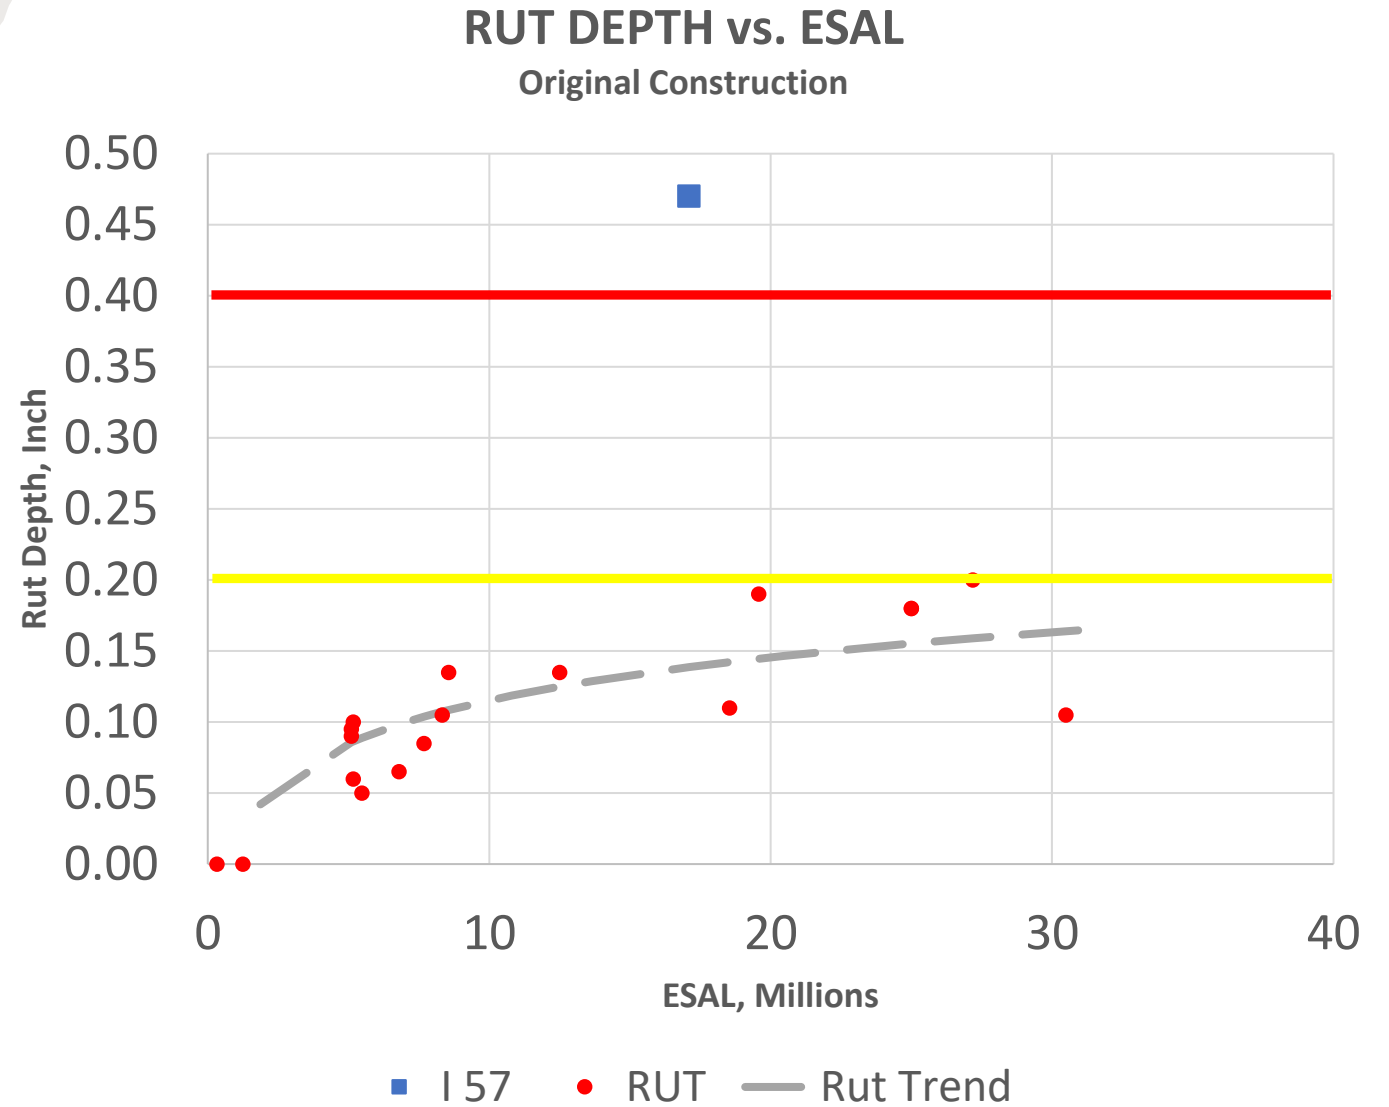
Rutting vs ESAL

- $Y = 0.1006\text{Log}X + 0.0146$
- $R^2 = 0.7262$

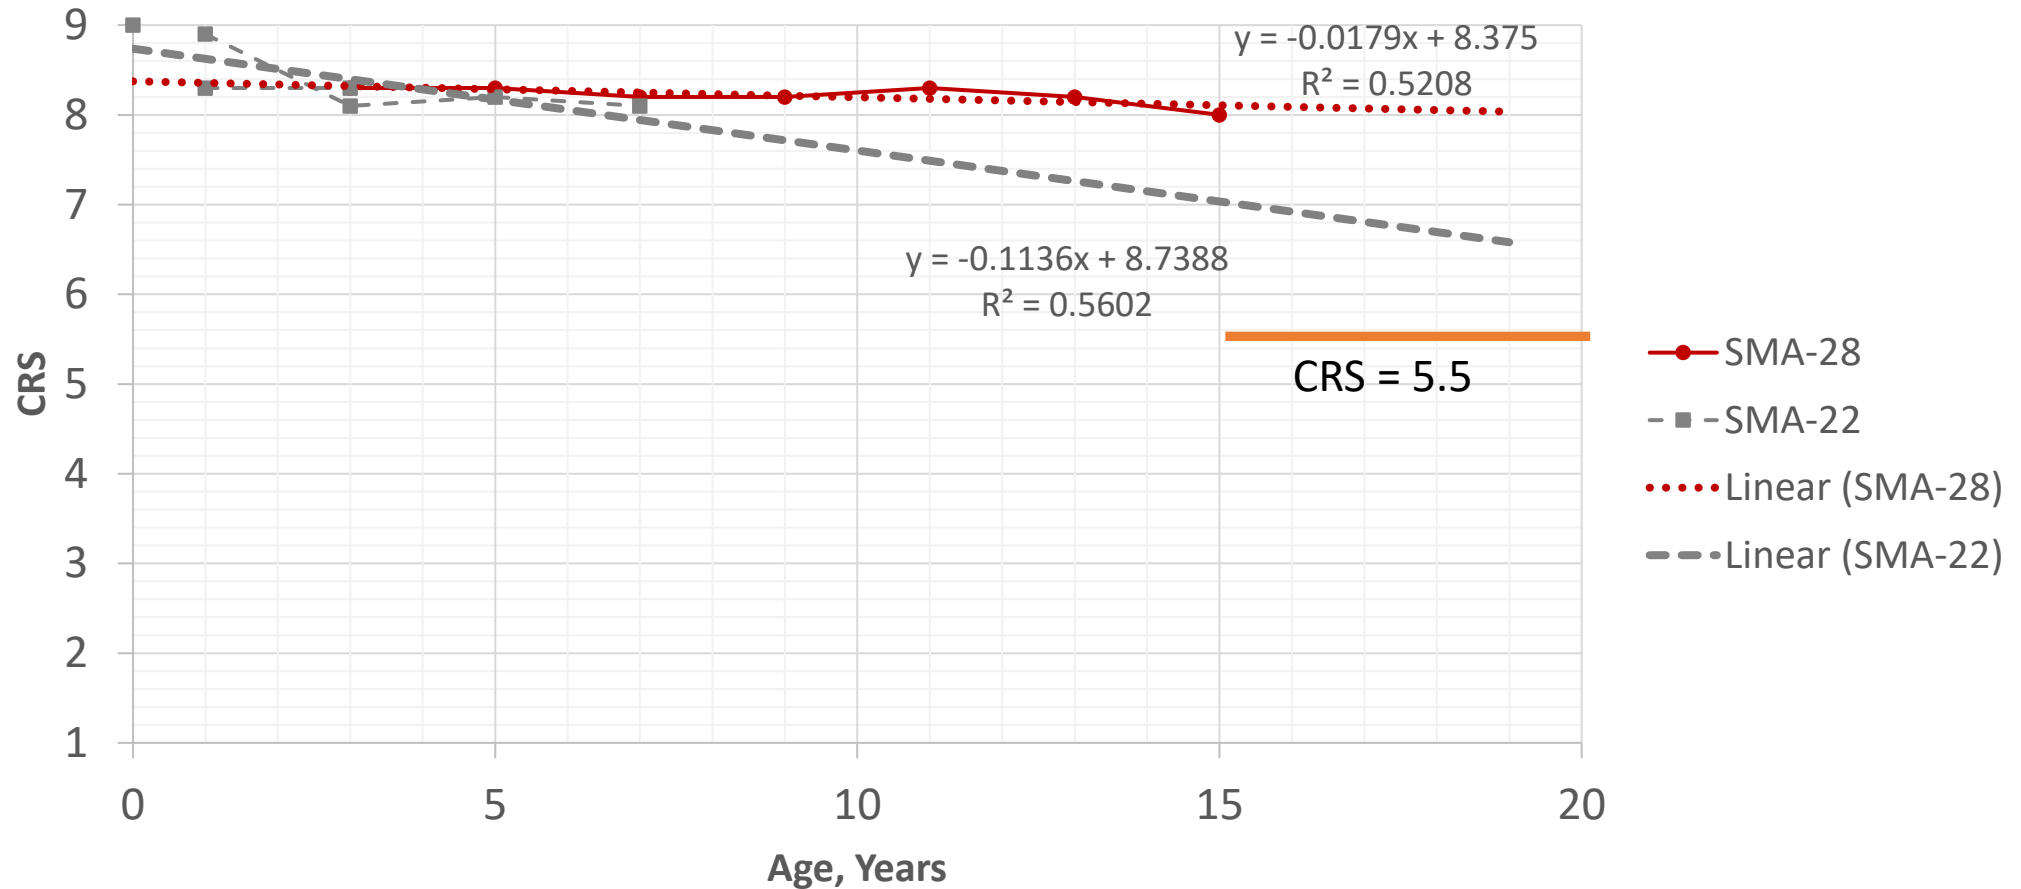
CRS vs. Section Age: SMA

CRS Trends SMA Sections

Surface Mix Group	Asphalt Binder Grade	Y-Intercept	Slope	R ²	Years to CRS of 5.5
IL-9.5	AC-20-PG64-22	8.78	-0.211	0.54	16
IL-9.5	Poly PGXX-22	8.77	-0.188	0.81	17
IL-9.5	Poly PGXX-28	8.52	-0.107	0.75	28
SMA	Poly PGXX-22	8.74	-0.114	0.56	28
SMA	Poly PGXX-28	8.38	-0.018	0.52	160
SMA (Last 3 data points)	Poly PGXX-28	9.14	-0.075	0.96	49

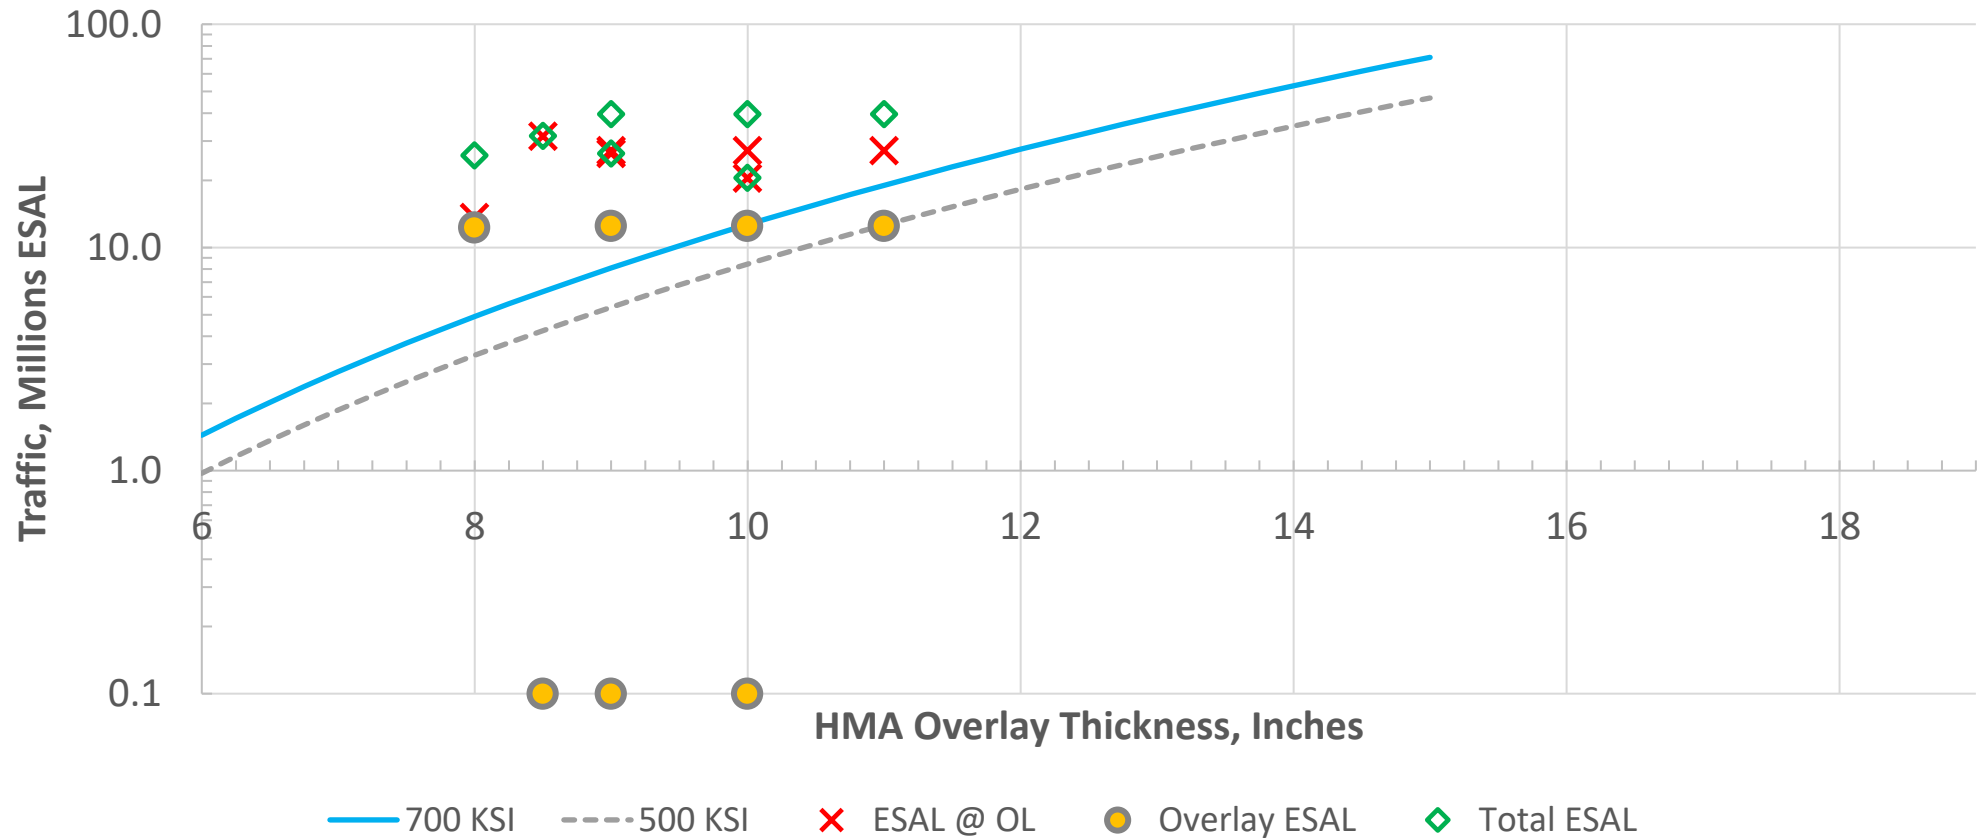
Design vs. Performance: Overlaid Sections

Rubblizing Design/Performance (2019)
ESAL on Overlay, Original Rubblizing and Total

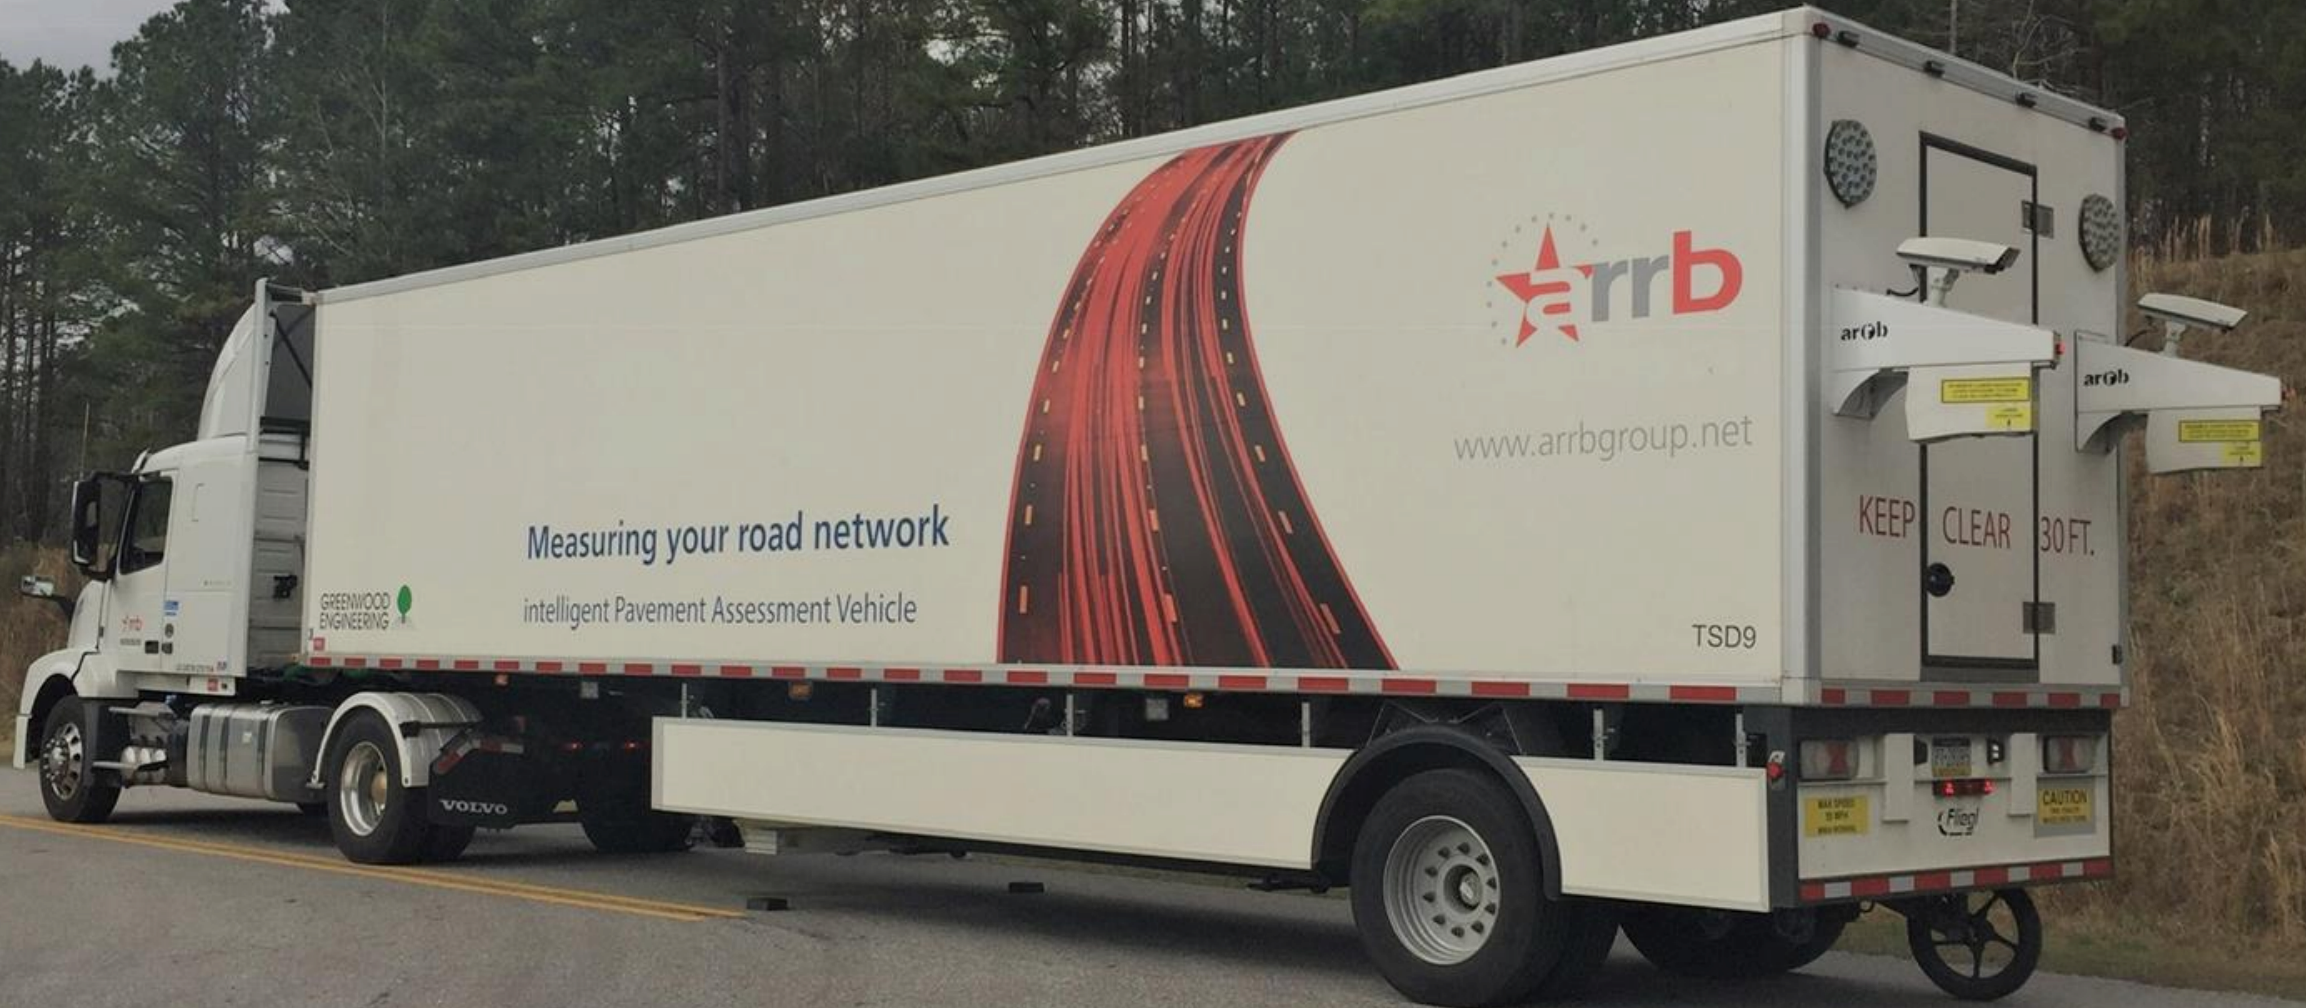
Traffic Speed Deflectometer (TSD)

- Device mounted in semi-trailer
- Data collected at traffic speed
- Pavement response measured with Doppler lasers
- Much more data collected per day
- Comprehensive pavement assessment

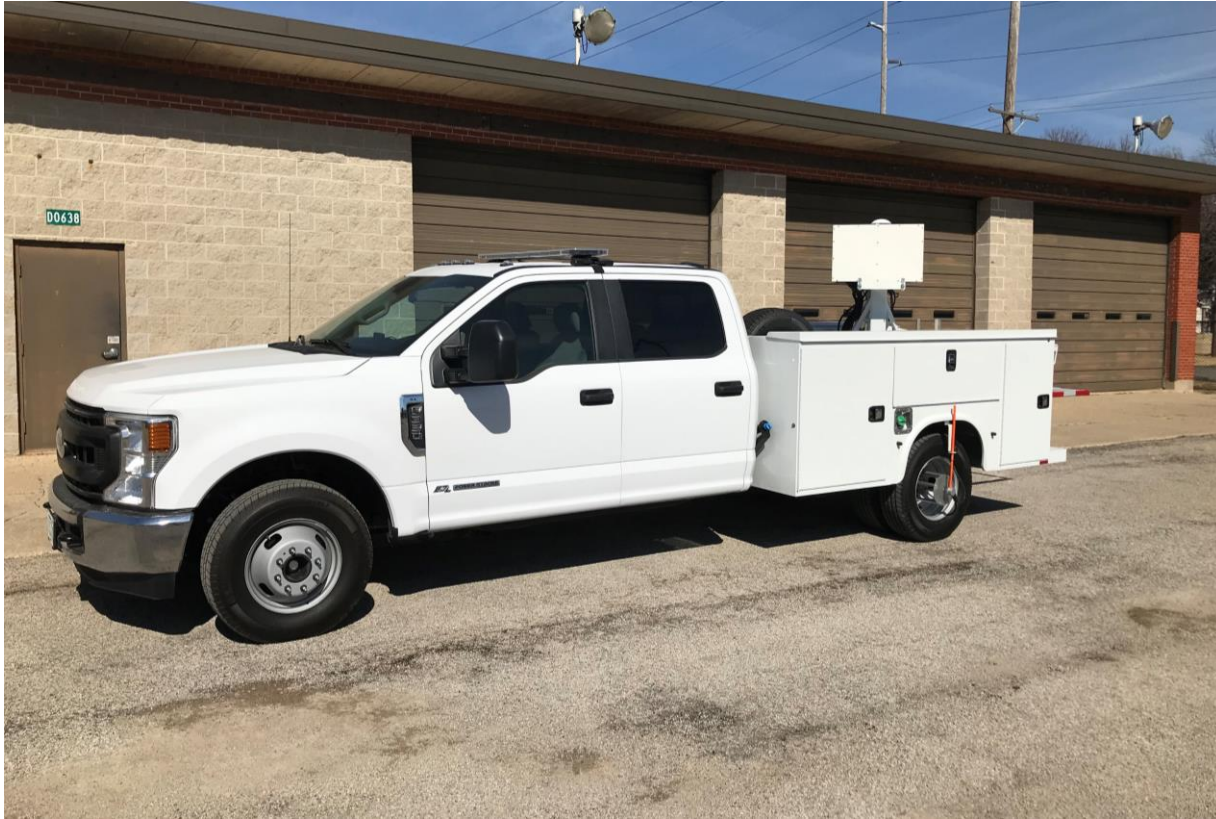
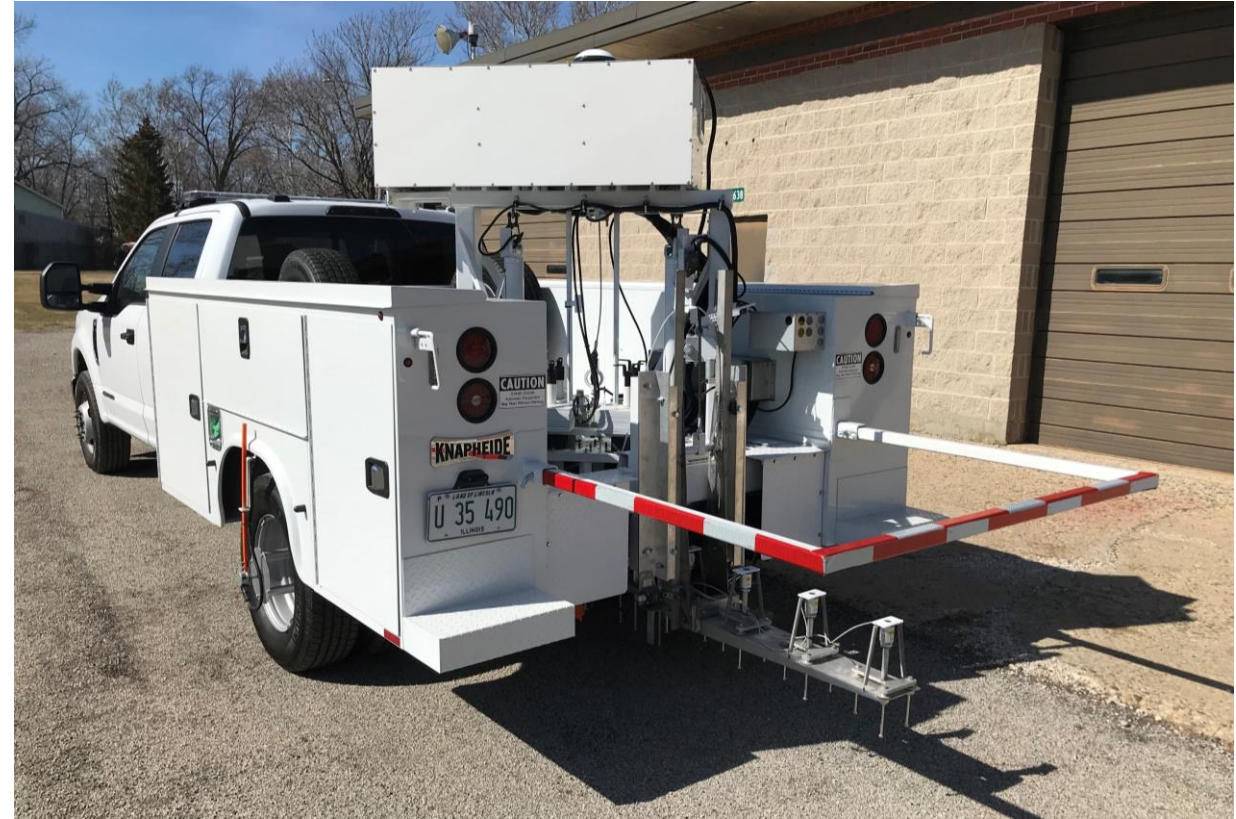
IDOT's New Truck-Mounted KUAB FWD

Falling Weight Deflectometer (FWD)

- Trailer or truck mounted
- Requires traffic control
- Load plate and sensors rest on pavement surface
- Limited productivity per day of testing

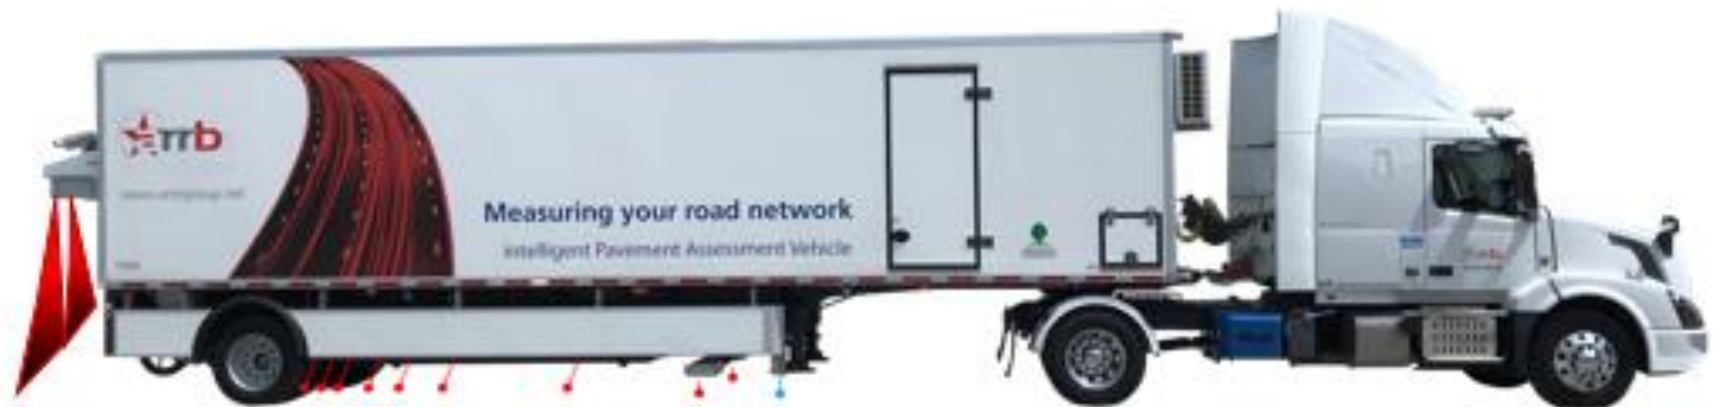
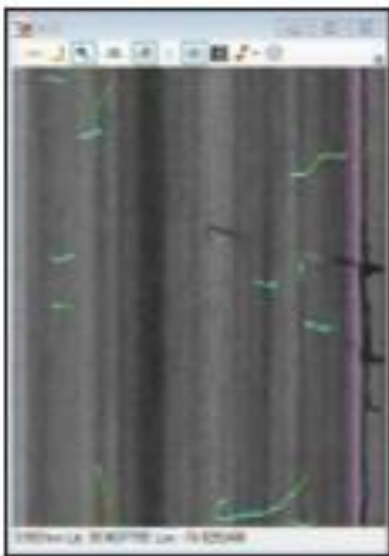
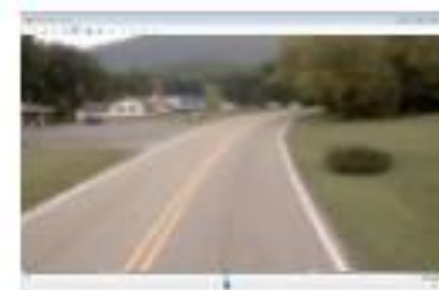
Comprehensive Pavement Assessment Capabilities

+ 3D Roughness
Full Lane

+ 3D Rutting
Full Lane

+ 3D Cracking
Full Lane

+ 3D Surface Defects
Full Lane

Continuous Deflection Measurement
Pavement velocity
Full Deflection Bowl
Applied Load
Surface & Air Temperature

+ Roughness
Left & Right wheel paths

+ Texture
Centre & Both wheel paths

+ GNSS DGPS
geospatial location

+ Geometry
Crossfall, Grade, Horizontal & Vertical curvature

+ Digital Imaging System

Simultaneous collection of Functional + Structural data = **Comprehensive Pavement Assessment**

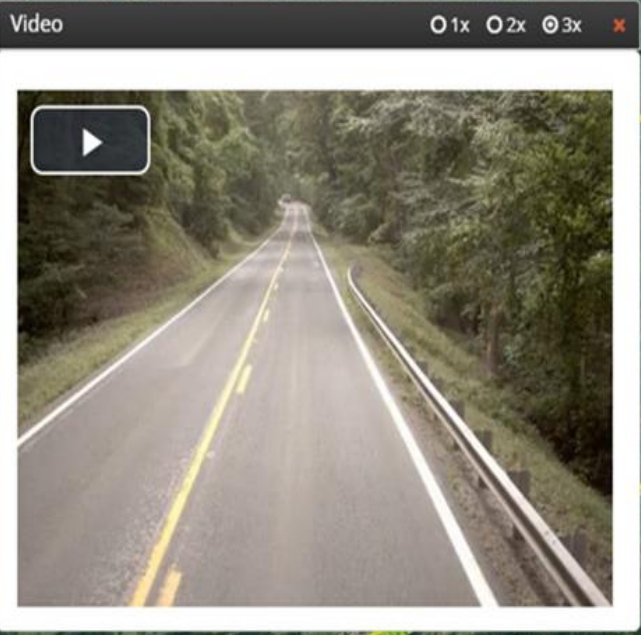
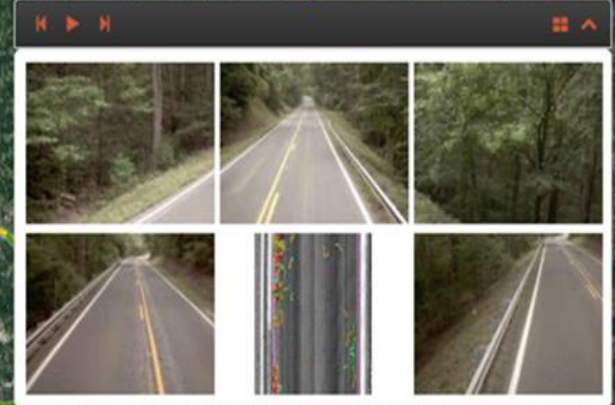
Maximum Deflection

Start Chainage:	11.95 mi
End Chainage:	12.01 mi
IRI_O:	73.5
Lane:	0
Project:	Virginia 2017
Less...	
D0 (mils)	-14.91122147
IRI Left	93.77
IRI Avg	83.64
IRI Lane	70.33
Rut Left (in)	0.053
Width Right (in)	90.192
Width Left (in)	65.54262
Cross Section Right (sq in)	4.770571
