BEST PRACTICES FOR BICYCLE TRAIL PAVEMENT CONSTRUCTION AND MAINTENANCE IN ILLINOIS

Research Report FHWA-ICT-12-009

**Developing Best Practices for Bicycle Trail
Pavement Construction and Maintenance in Illinois**

June 2012

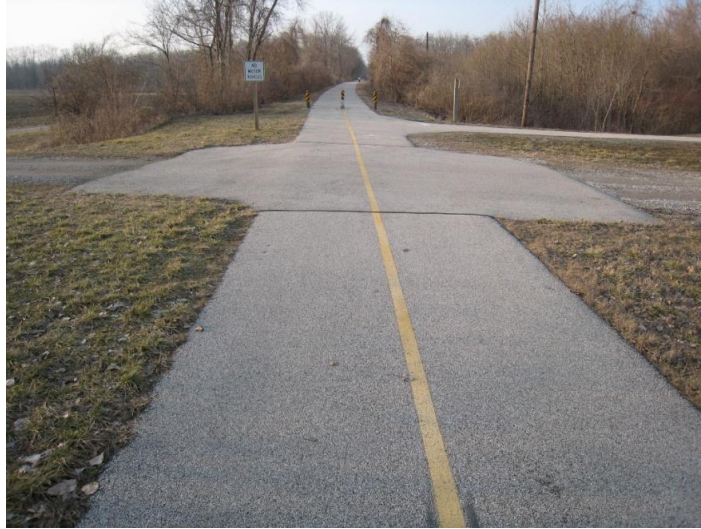
This trail had some crossings with farm access roads, as shown in Figure D.37. In addition to widening the pavement at the road crossing to reduce the amount of gravel being tracked onto the trail, the pavement is thickened at the road crossing. Generally, the road crossing is constructed with 5 inches of HMA or 6 inches of PCC.

Figure D.37. Typical asphalt farm road crossing.

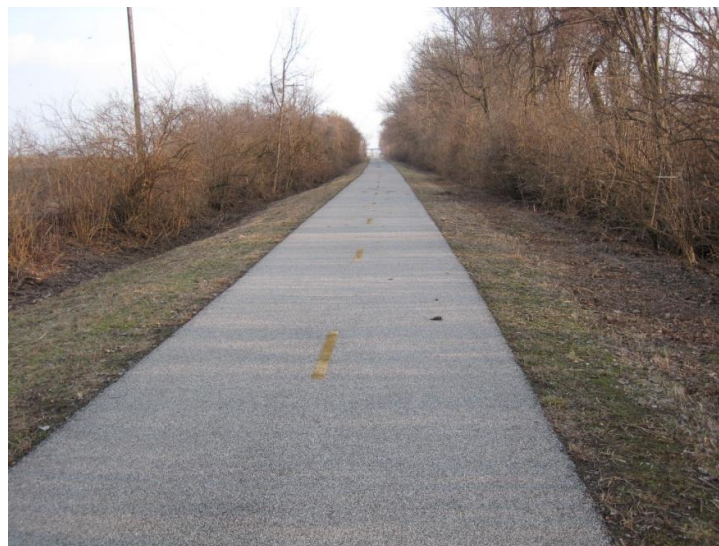
This trail was in outstanding condition. Like the Nature Trail, there were no thermal cracks present. As shown in Figure D.38, there was good vegetation clearance and pavement edge support. Some areas had low-severity longitudinal cracking, as shown in Figure D.39. One localized area of binder bleeding was observed, as shown in Figure D.40.

Figure D.38. Good edge support and vegetation clearance.
