Rubblization Performance History

Charles Wienrank, P.E.

Bureau of Materials and Physical Research

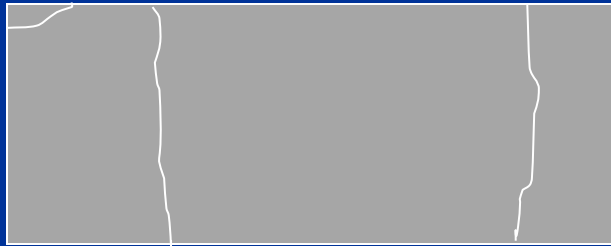
Rubblization

PCC Slab

HMA Overlay

**Rubblized PCC Slab -
75% of pieces < 9"
in lower half**

- ***Reconstruction*** alternative for deteriorated concrete pavements
 - Substitute for extensive patching or complete removal and replacement
- Pavement in effect becomes a high-quality, moderately drainable aggregate base
- Eliminates virtually all reflective cracking in the overlay

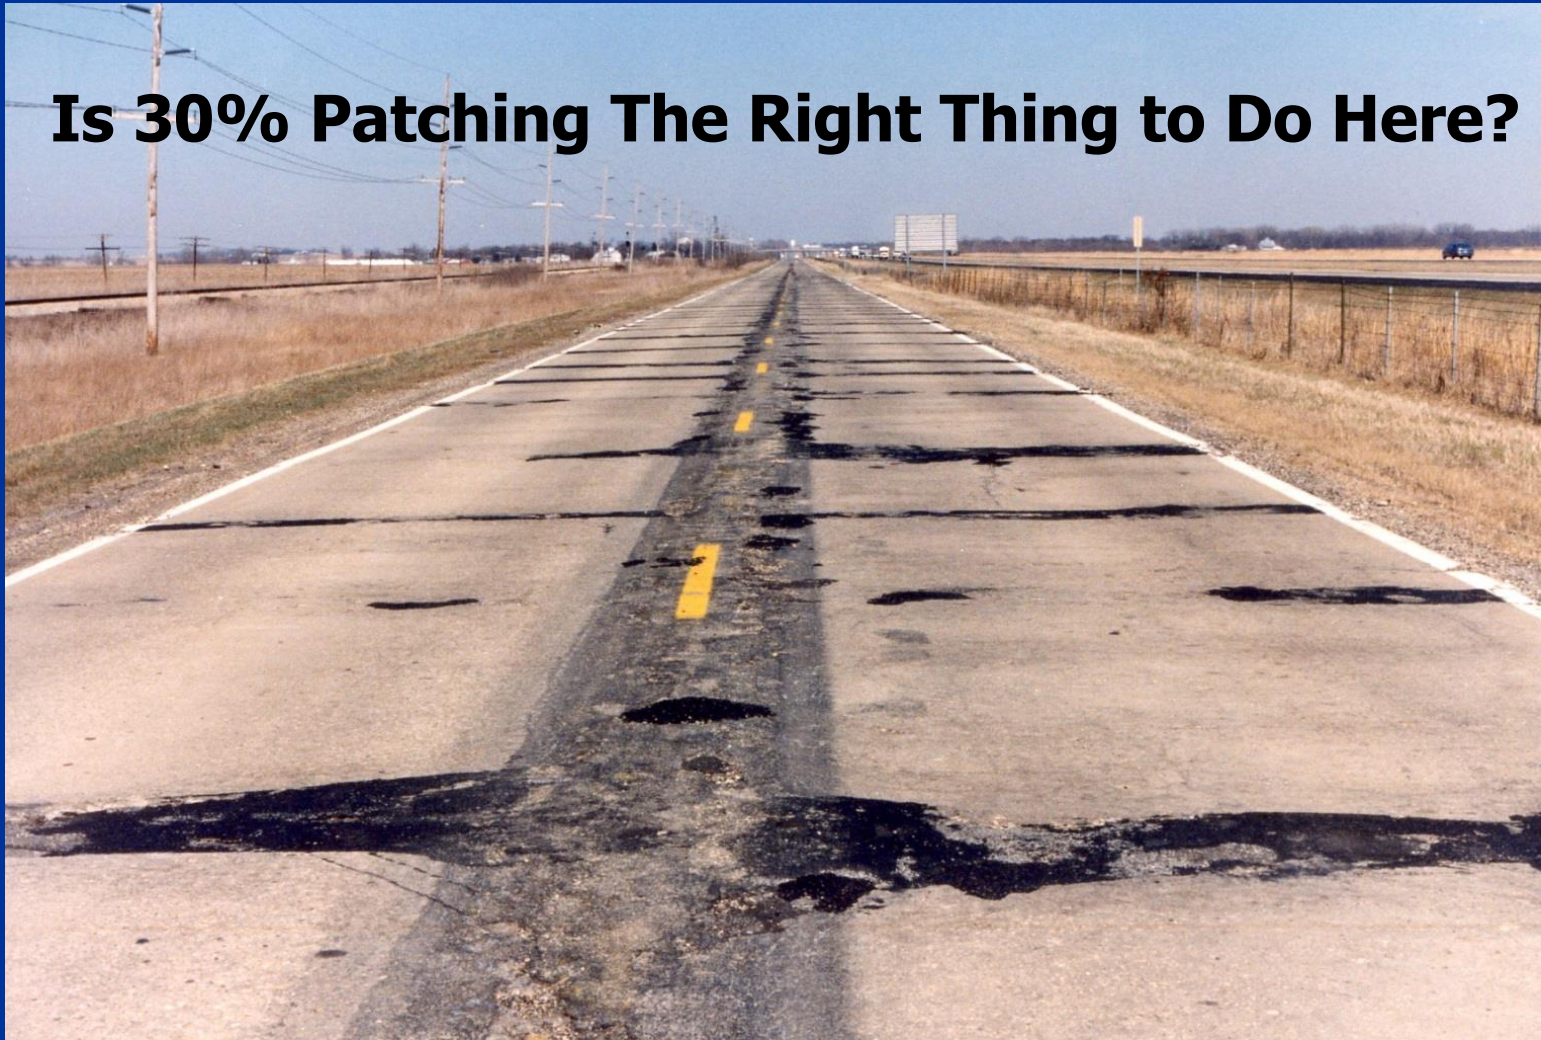
Prime Rubblization Candidate

Is 30% Patching The Right Thing to Do Here?

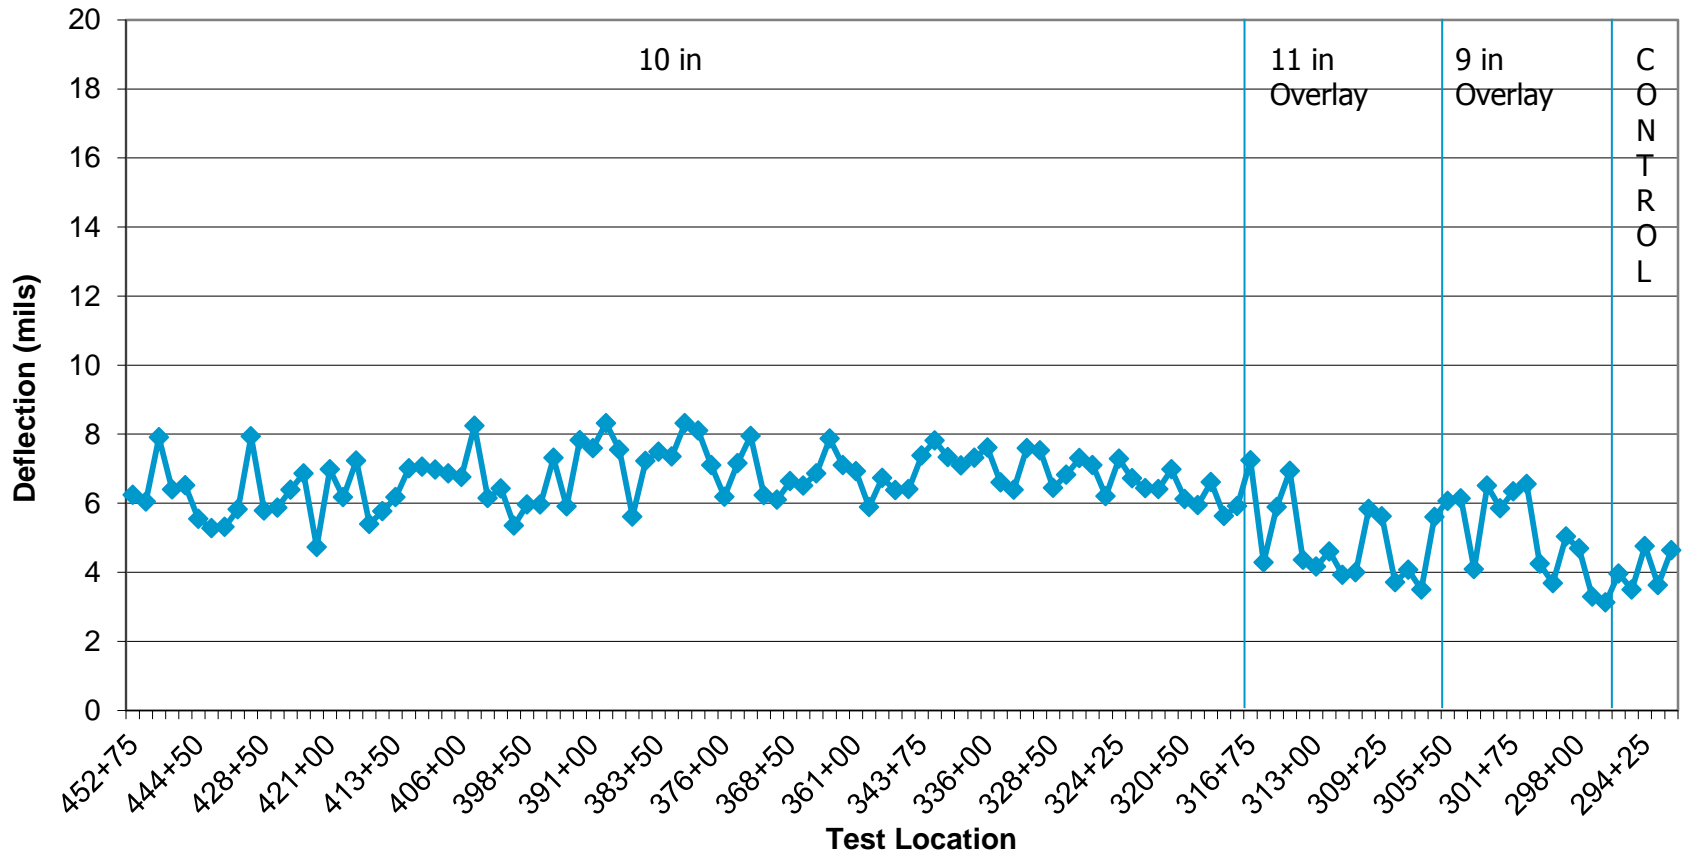
FWD Deflection Profile - I-70 WB Rubblizing Contract 90675
District 7 Cumberland County - 7/26/2013
